# Redefining dryland salinity for a new generation of land managers

**Liebe Group**

**Contour Environmental and  
Agricultural Consulting**

July 2022

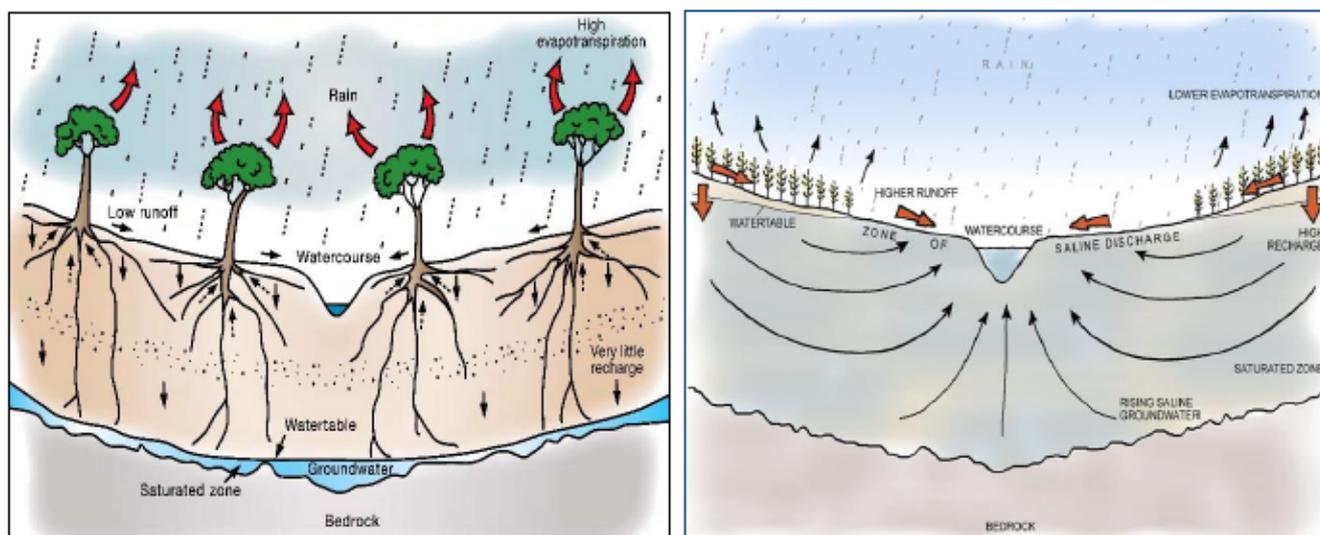
Figure 3.1 Depiction of how dryland salinity occurs – a healthy balanced system on the left - removing trees on the right leading to a high-water table and bringing salt to the surface. (Smith 2007)

The southwest of Australia has had trace amounts of salt deposited by rainfall for millions of years. Native vegetation is very efficient at using nearly all the available water as it infiltrates through the soil profile so that very little water gets below the root zone to 'recharge' the water table. When water does get below the root zone it takes the salt too where it accumulates and concentrates creating saline groundwater above the bedrock but usually well below the surface.

The progressive clearing and replacement of native vegetation with shallow rooted annual crops created a leaky system, with a decrease in transpiration, regular annual recharge, and saline groundwater rise, sometimes dramatically, across the agricultural areas.

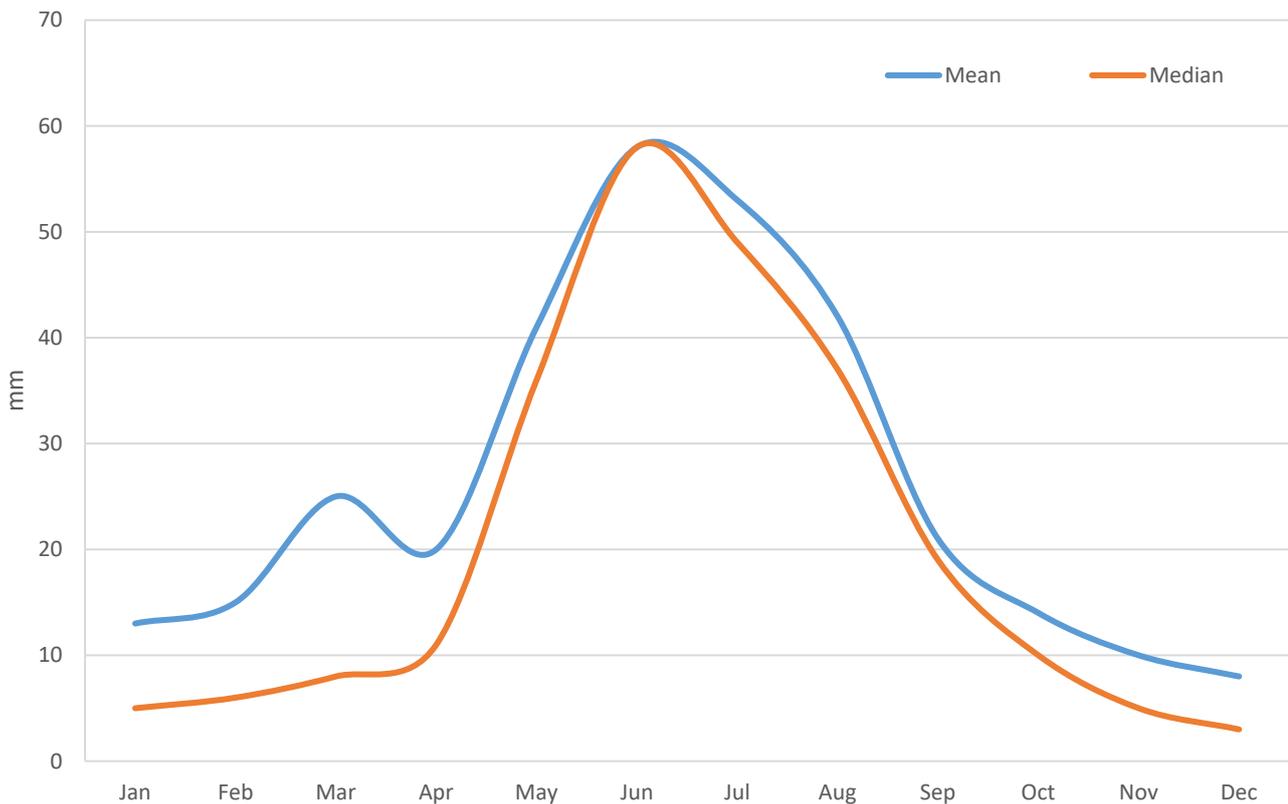
**Figure 5.1 Long term median versus mean rainfall for Liebe Group salinity project catchment**

Figure 5-1 above shows the long term monthly median rainfall against the long-term average rainfall. It is a useful way to highlight reliability of rainfall as the closer the lines are together, the more reliable. Due to the nature of summer rain events, it is expected that summer months would show greater unreliability, and because of cold fronts consistently moving through the southwest land division between June and September, these months have greater reliability, and is the basis of agricultural production systems of the area.

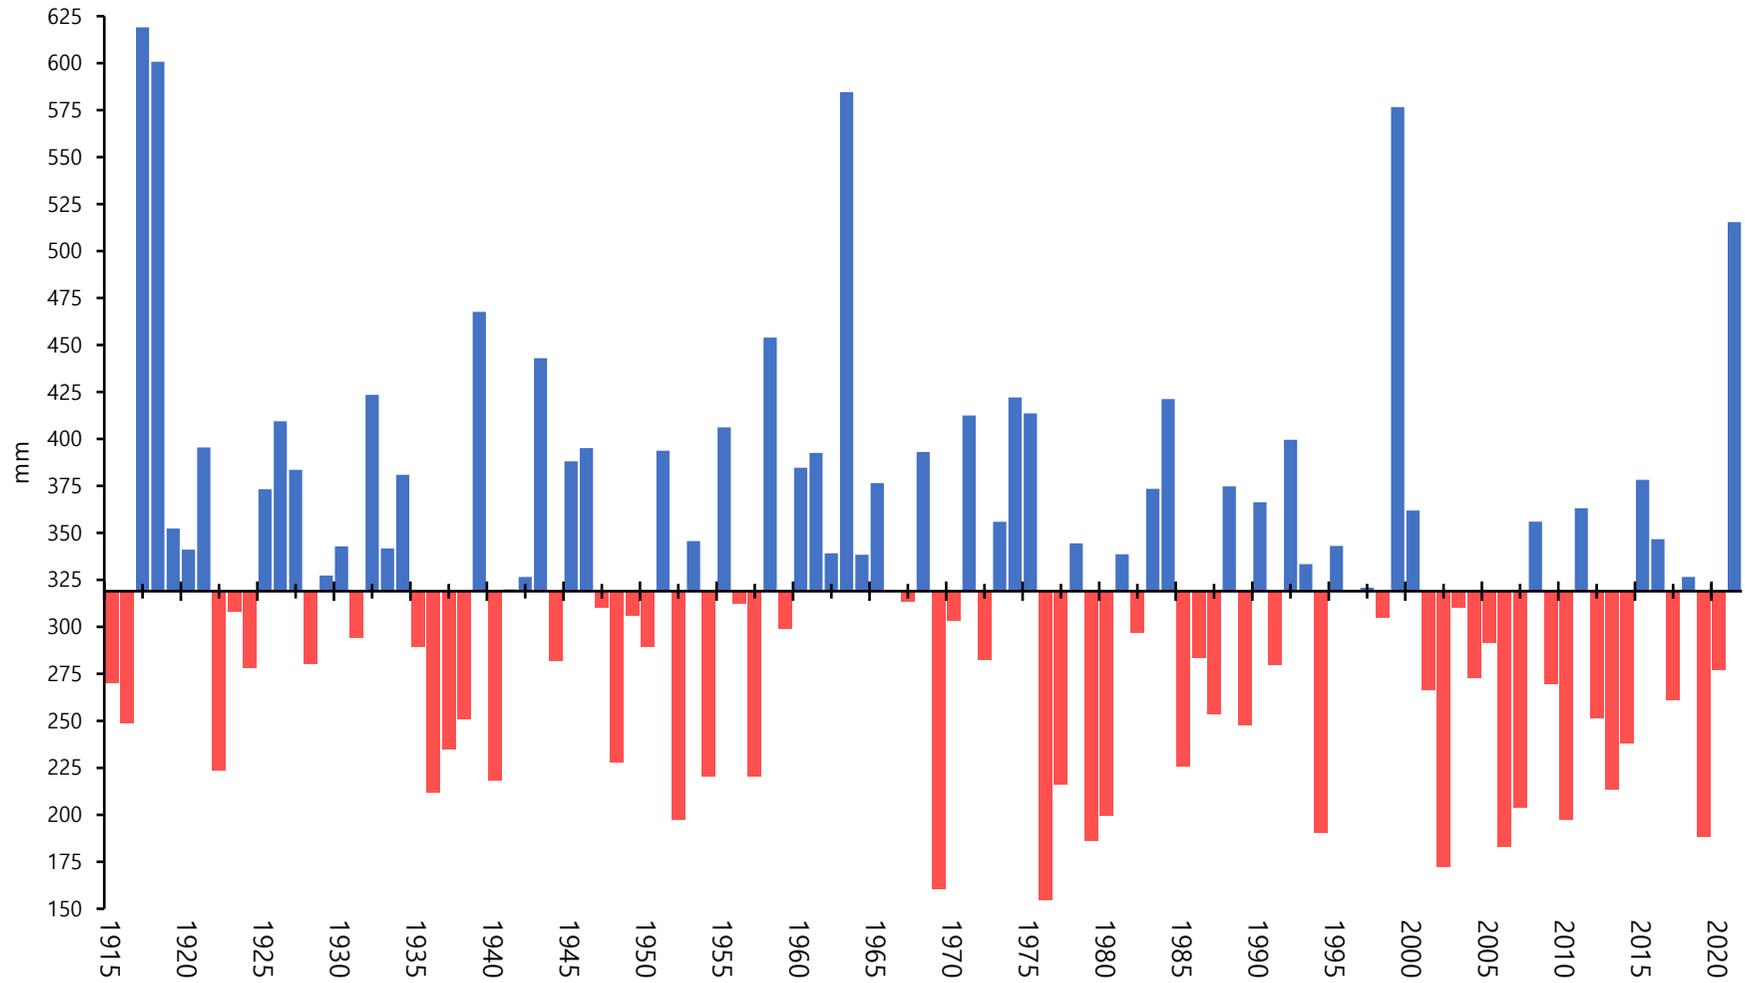
Figure 5.2 Long term annual rainfall showing years above and below the median rainfall for the Liebe Group salinity project catchment.

1999 and 2021. It is interesting to note that the longest period of below median rainfall was 2001-2007, a time when salinity related activity in the current project catchment was perhaps at its peak. The 1970s was also a particularly dry period in the SW corner of Australia, in contrast to the rest of the country. Also worth noting is that, since 2000, even in those years exceeding the median, rainfall was still not much above the long-term average, peaking at 378 mm in 2015. This further highlights what an exceptional year 2021 was.

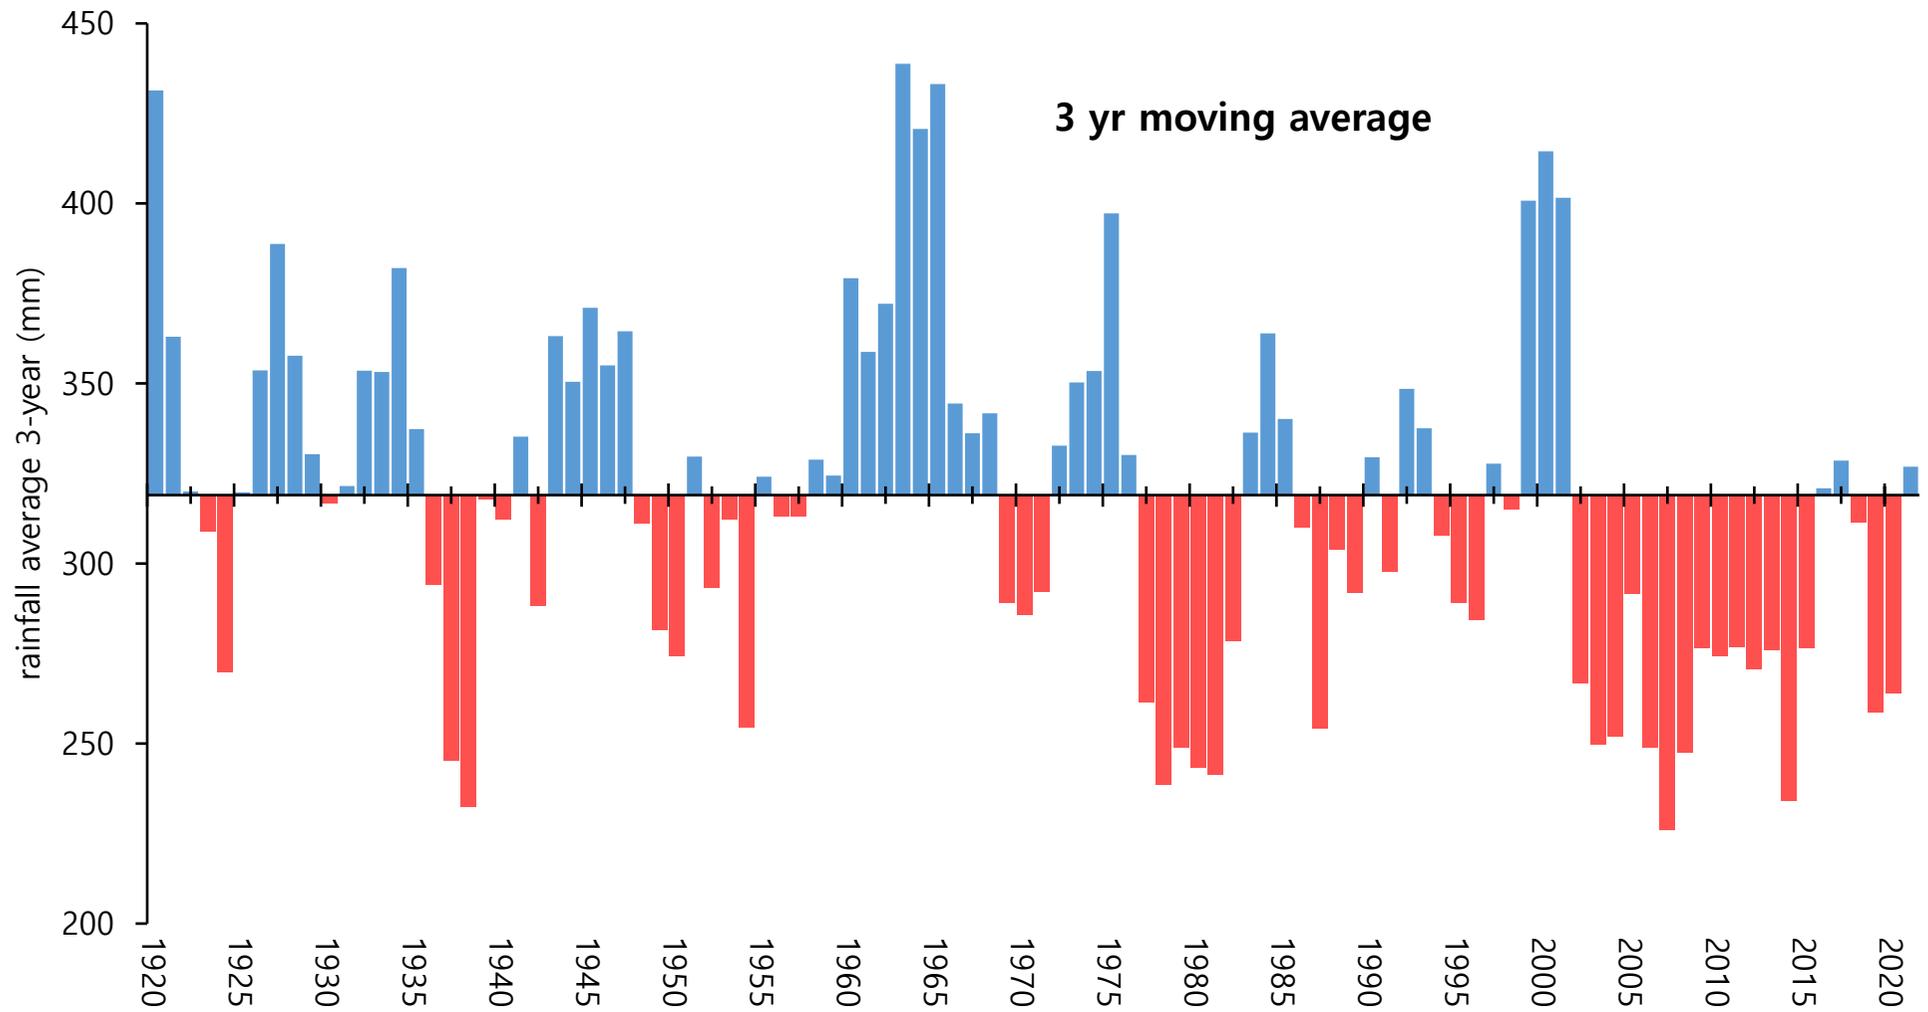
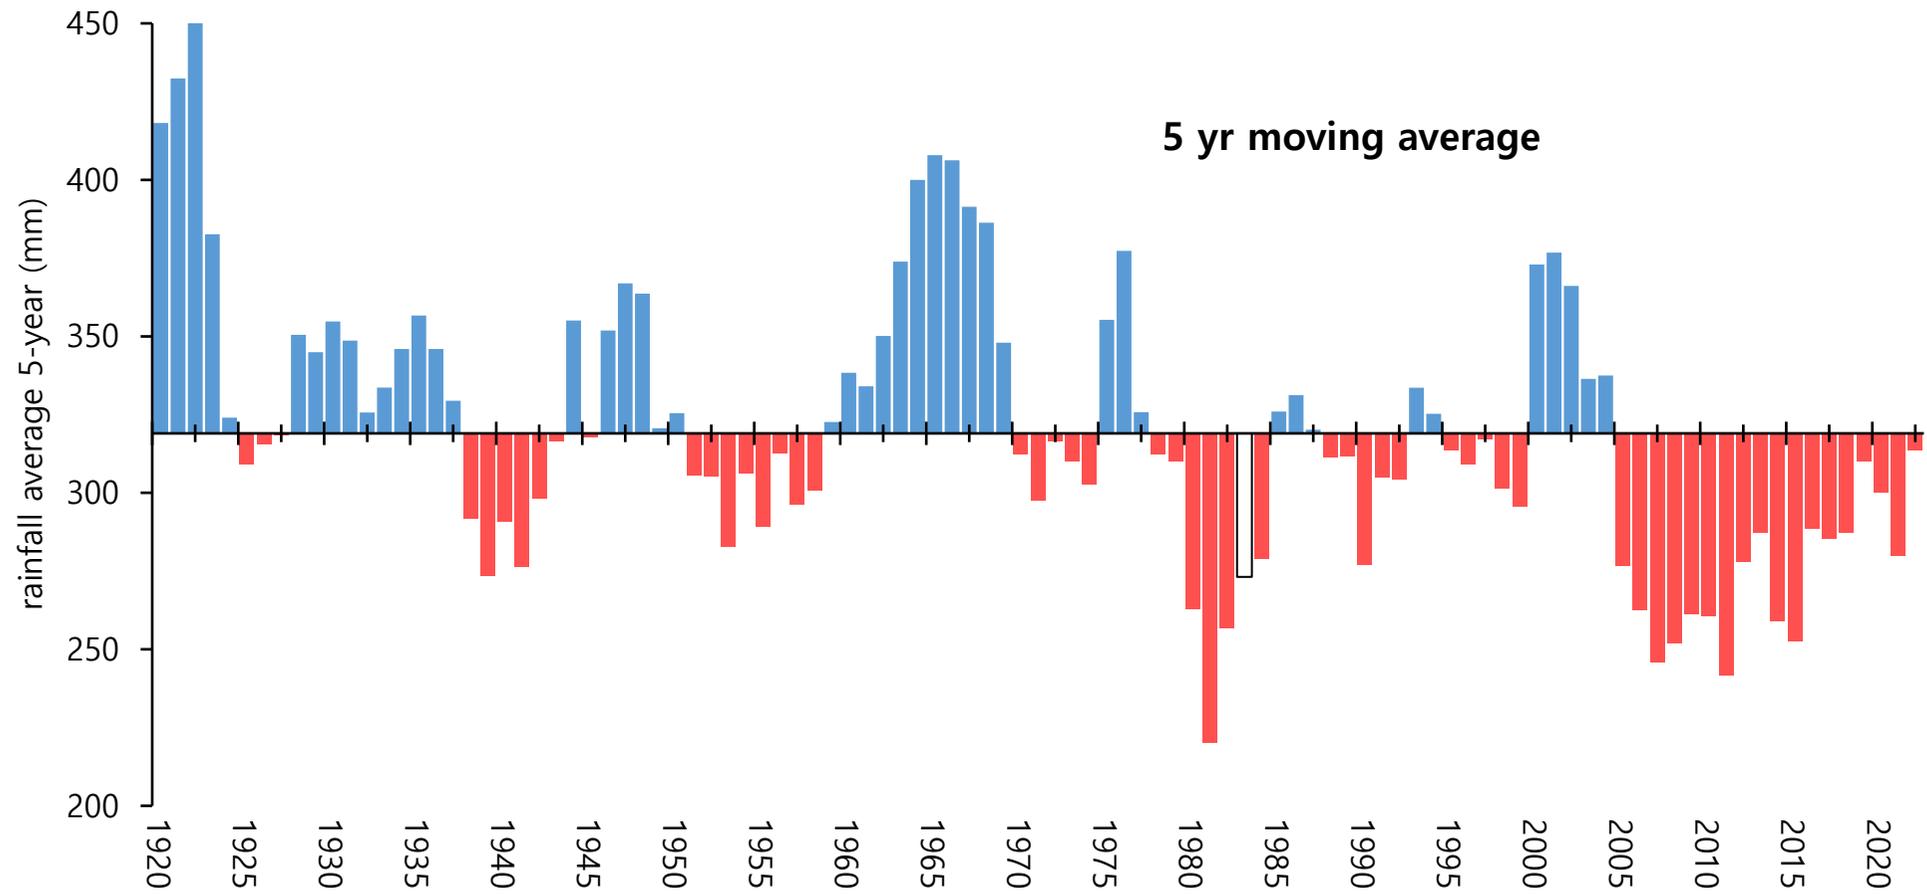
Figure 5.3 Three-year and five-year moving average rainfall against long term median – Liebe Group salinity project

Figure 5-3 below shows the three-year moving average of rainfall against the long-term median as well as the five-year moving average for the project catchment. It shows that in the last century there have been periods of above and below average rainfall, and this accumulation or run of seasons has likely influenced groundwater levels and salinity, at least since widespread broadscale clearing. Apart from periods such as the wet 1960s and dry late 1970s and early 1980s, the other noticeable period is the ongoing lower cumulative rainfall since 2004. Two good years in a row (2015 and 2016) reversed the trend before dry years again in 2019 and 2020. The very wet year in 2021 has seen the three-year average again go above the long-term median but in the longer-term five-year running, declining rainfall year after year remains the trend.

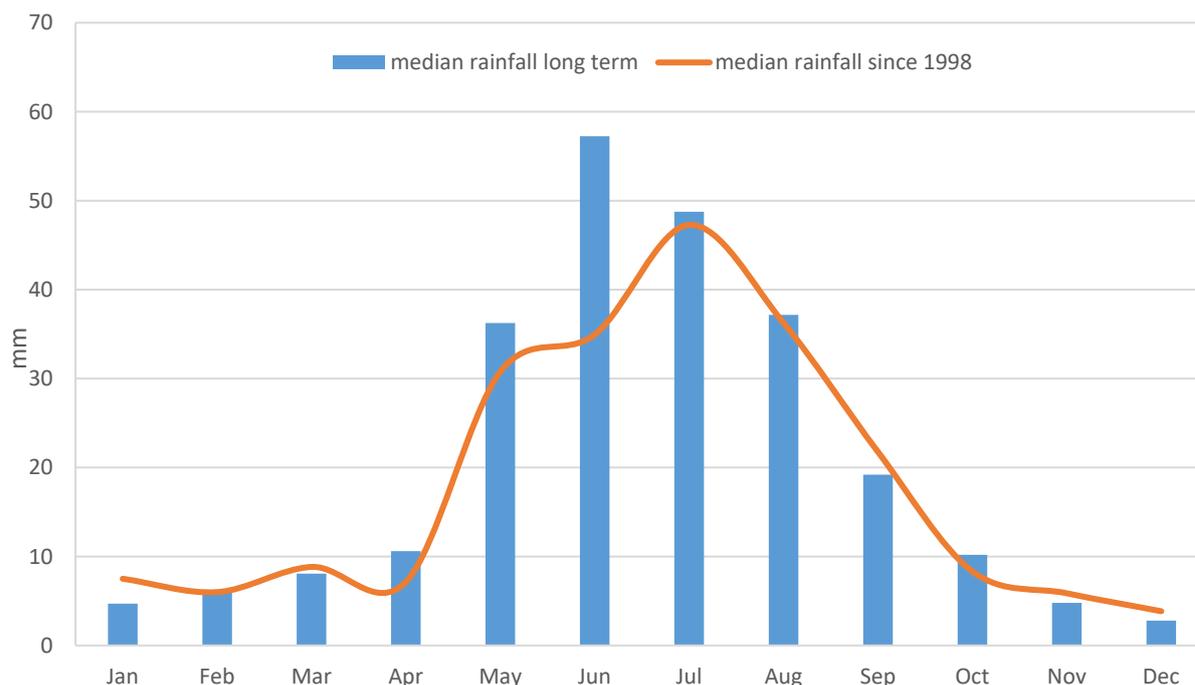
**Figure 5.4** Median long-term rainfall for the Liebe Group salinity project against the median since 1998

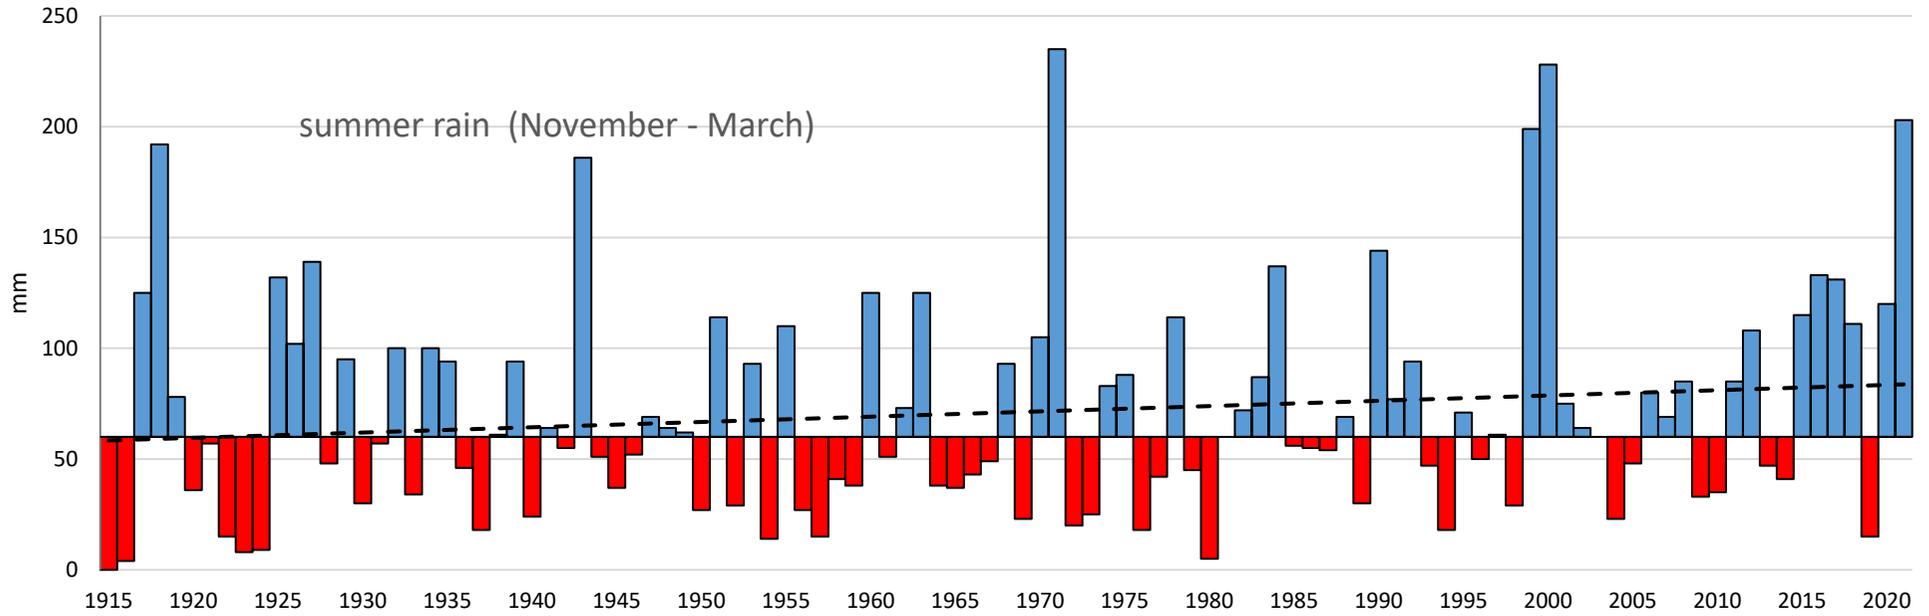
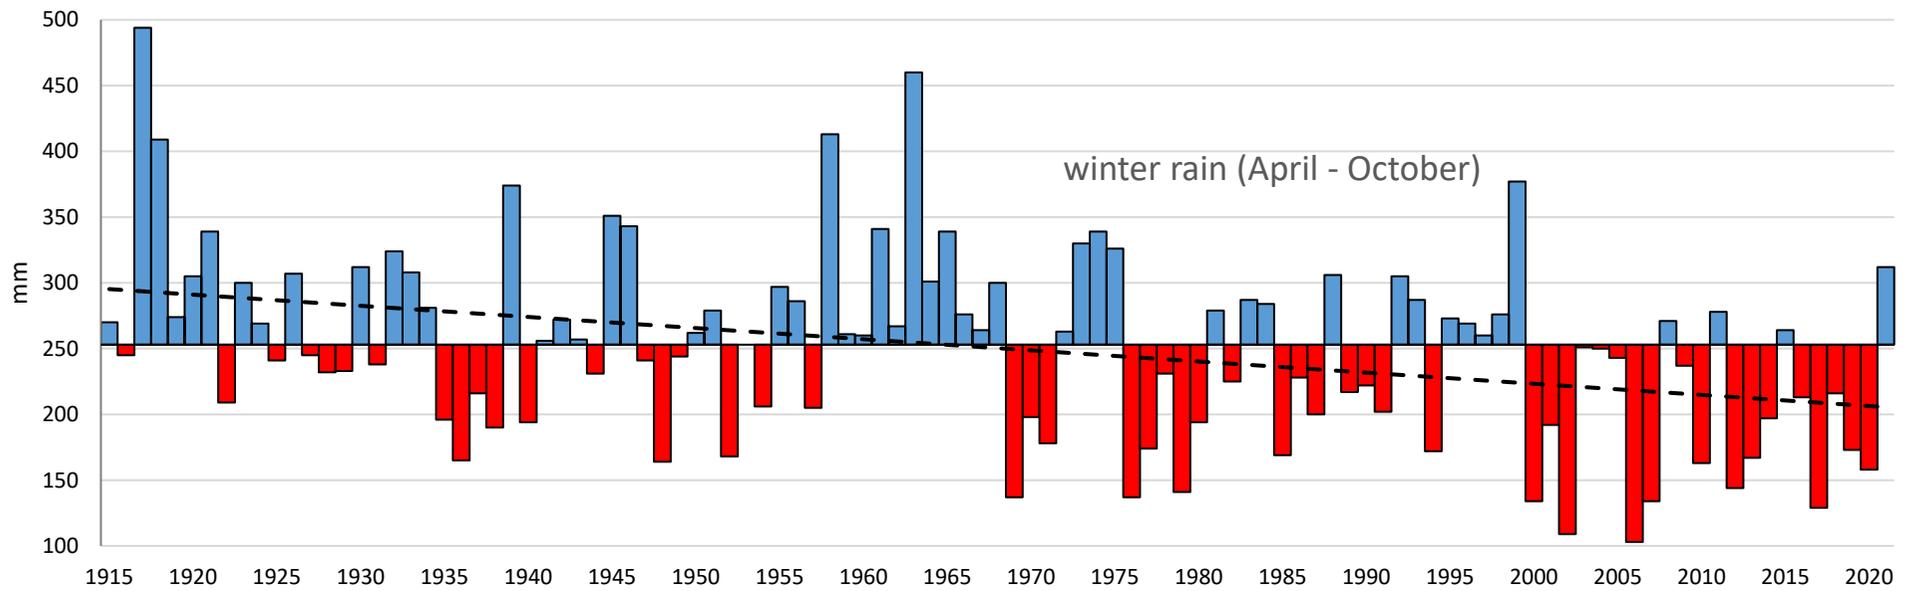
Figure 5.5 summer versus winter rainfall trends in the Liebe Group salinity project catchment

median than below, 15 summers above the median, and seven below. The main difference in terms of the salinity spike following the 1999 rainfall events is that at that time, very high winter rain followed summer rain. This has not occurred since, although 2021 does show some characteristics of 1999 where good winter rains followed high summer rainfall.

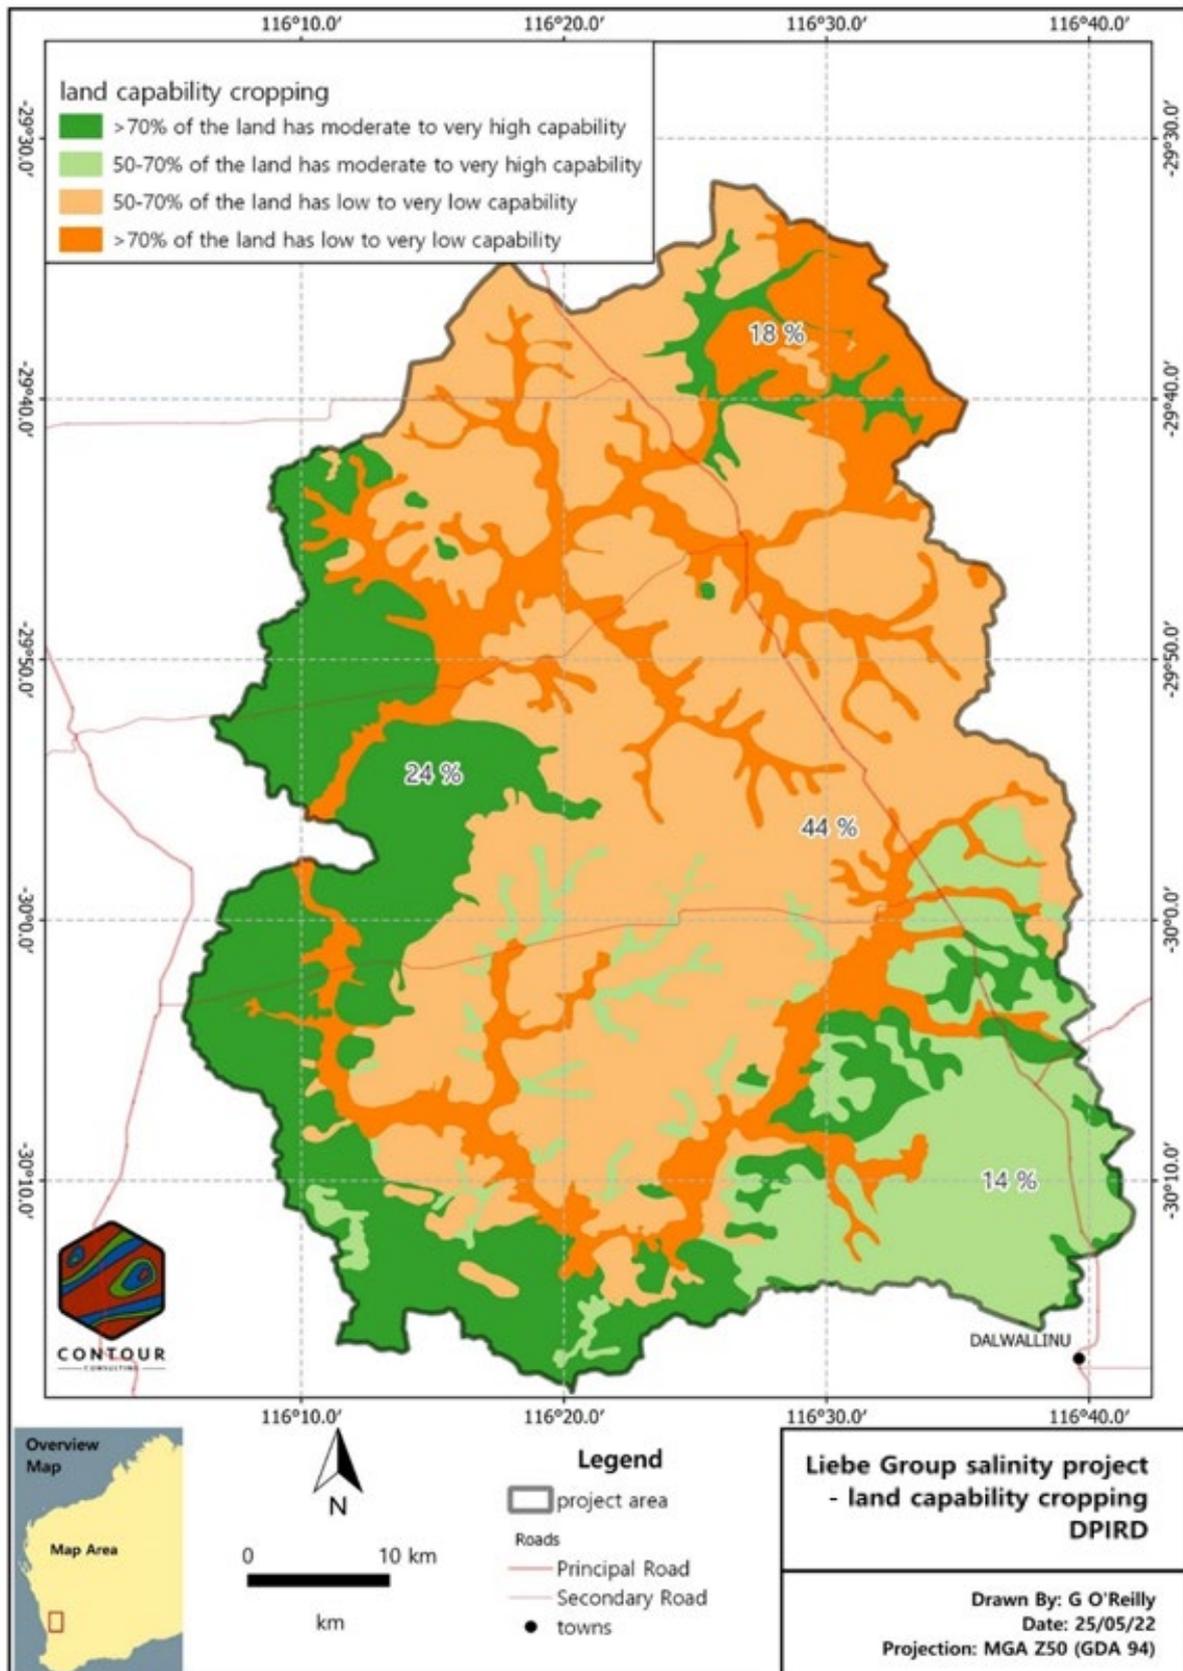
Figure 6.1 Land capability for cropping including percent area in the Liebe Group project catchment area

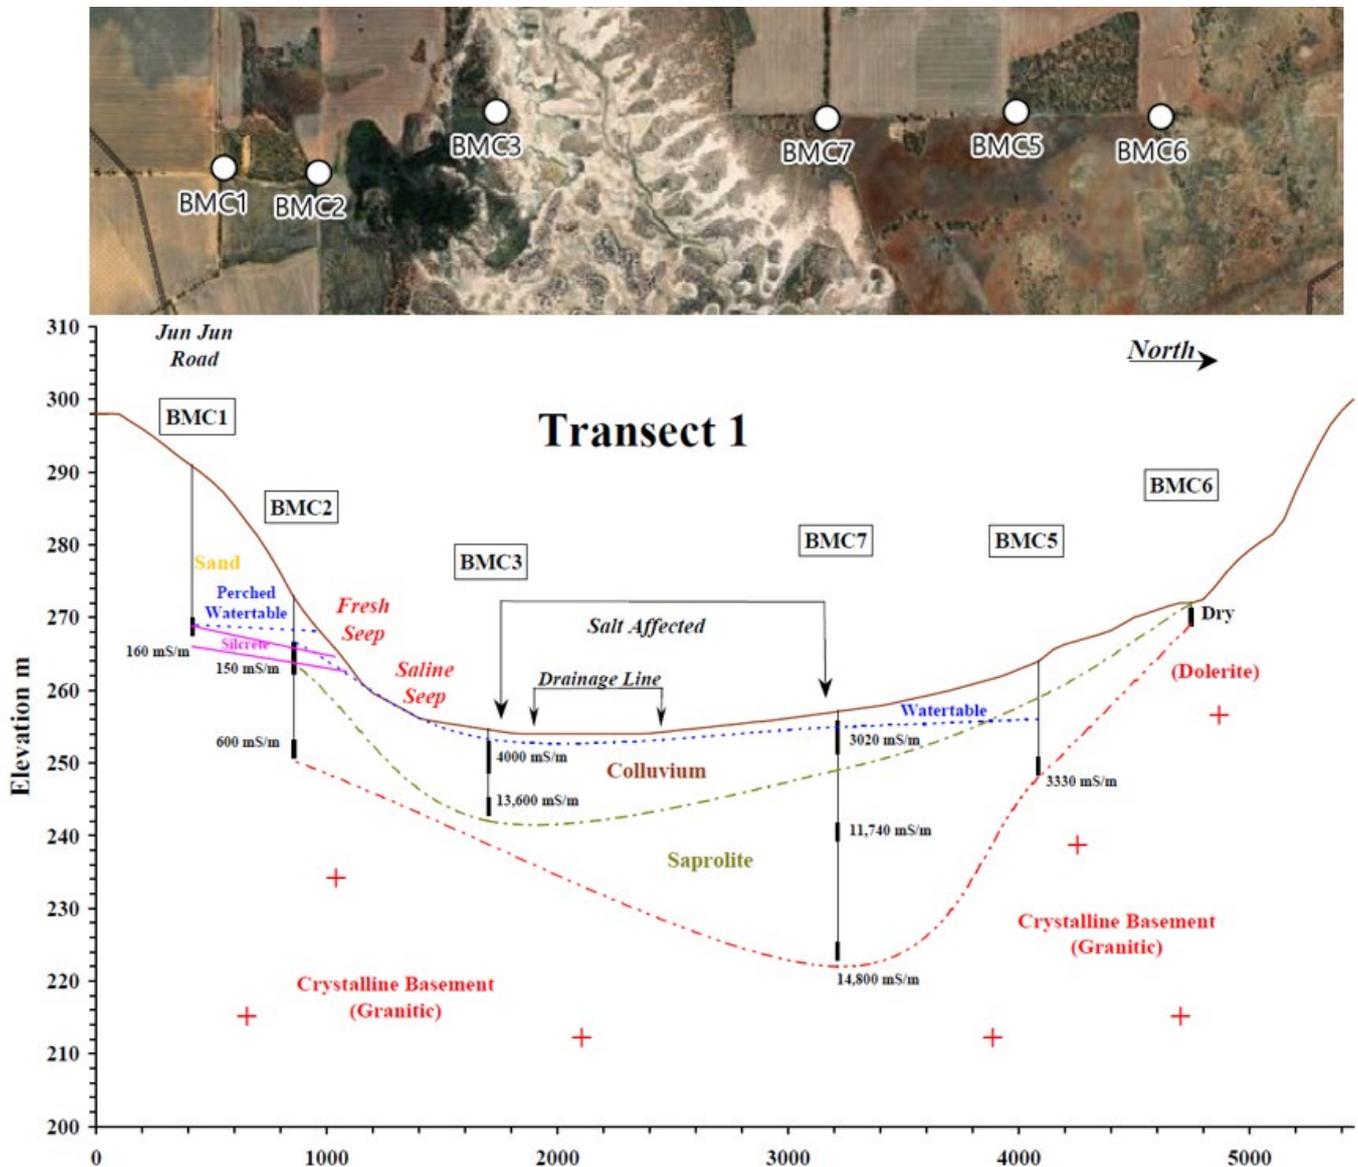
Figure 6.2 Typical hydrogeological cross section in the project catchment – adapted from (Speed and Strelein 2004)

Continuing downslope, bore BMC3 drills through the very shallow saline water table (1.5 m deep) into a thick colluvium layer. These deep (up to 38 m) alluvial deposits were found to be a feature of the BMNDRC investigations and represent sediment deposited perhaps millions of years ago.

From BMC3 to BMC7 is the salt affected land where the water table affects the growth of vegetation on the surface. Note that salinity (measured in mS/m) increases with depth through the saturated colluvium into the saprolite. BMC7 hit bedrock at 35 m and the water table was at 3.1 m below the surface. That represents a huge volume of saline groundwater.

Moving out onto the other side of the water course into cropping land and the water table drops. Bore BMC6 quickly hit bedrock and was dry in 2002 and 2006.

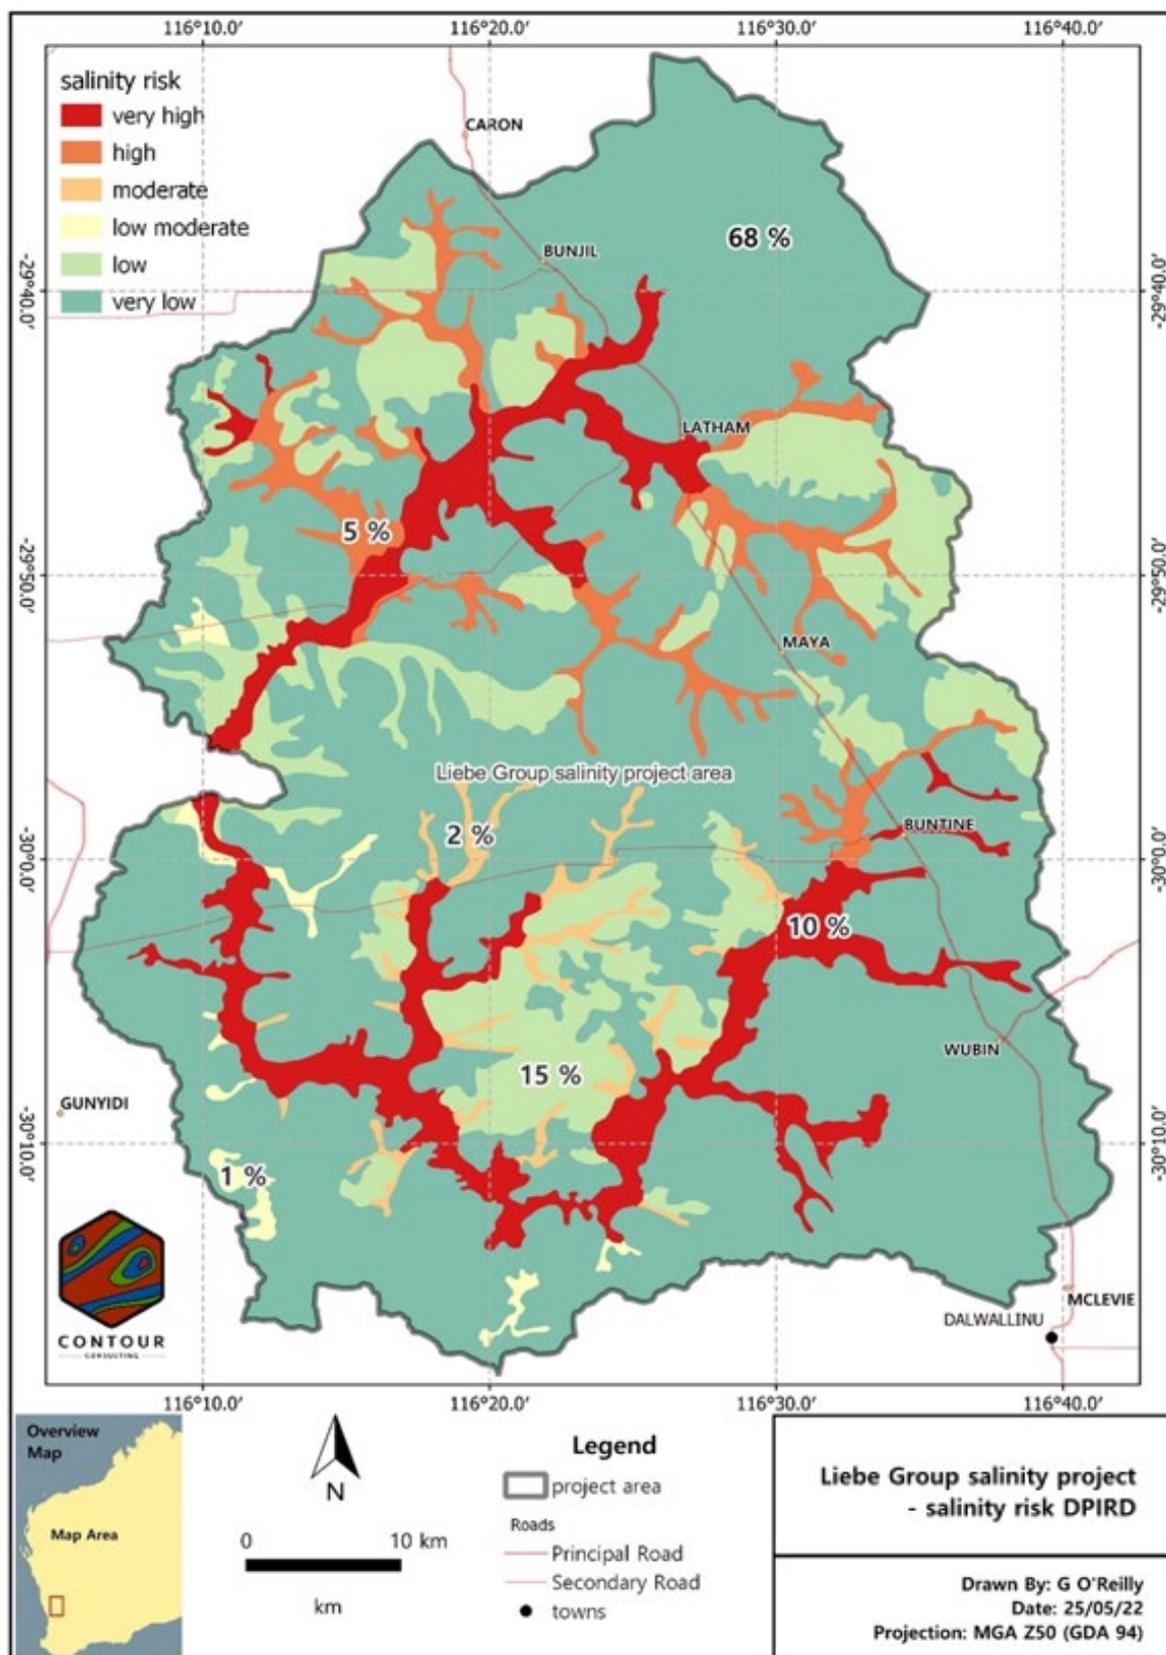
Figure 6.3 General salinity risk in the Liebe Group project catchment

chance of moderate to high salinity risk. This means that 15 percent of the catchment is, or already is, potentially affected by salinity. A further 15 percent of the catchment is considered low risk but could still have small areas of salinity or potential to become saline. Salinity and waterlogging are closely related, and this is discussed further in tackling salinity. Once again sub-system landscape data has been used to show waterlogging risk in the project catchment in Figure 6-4.

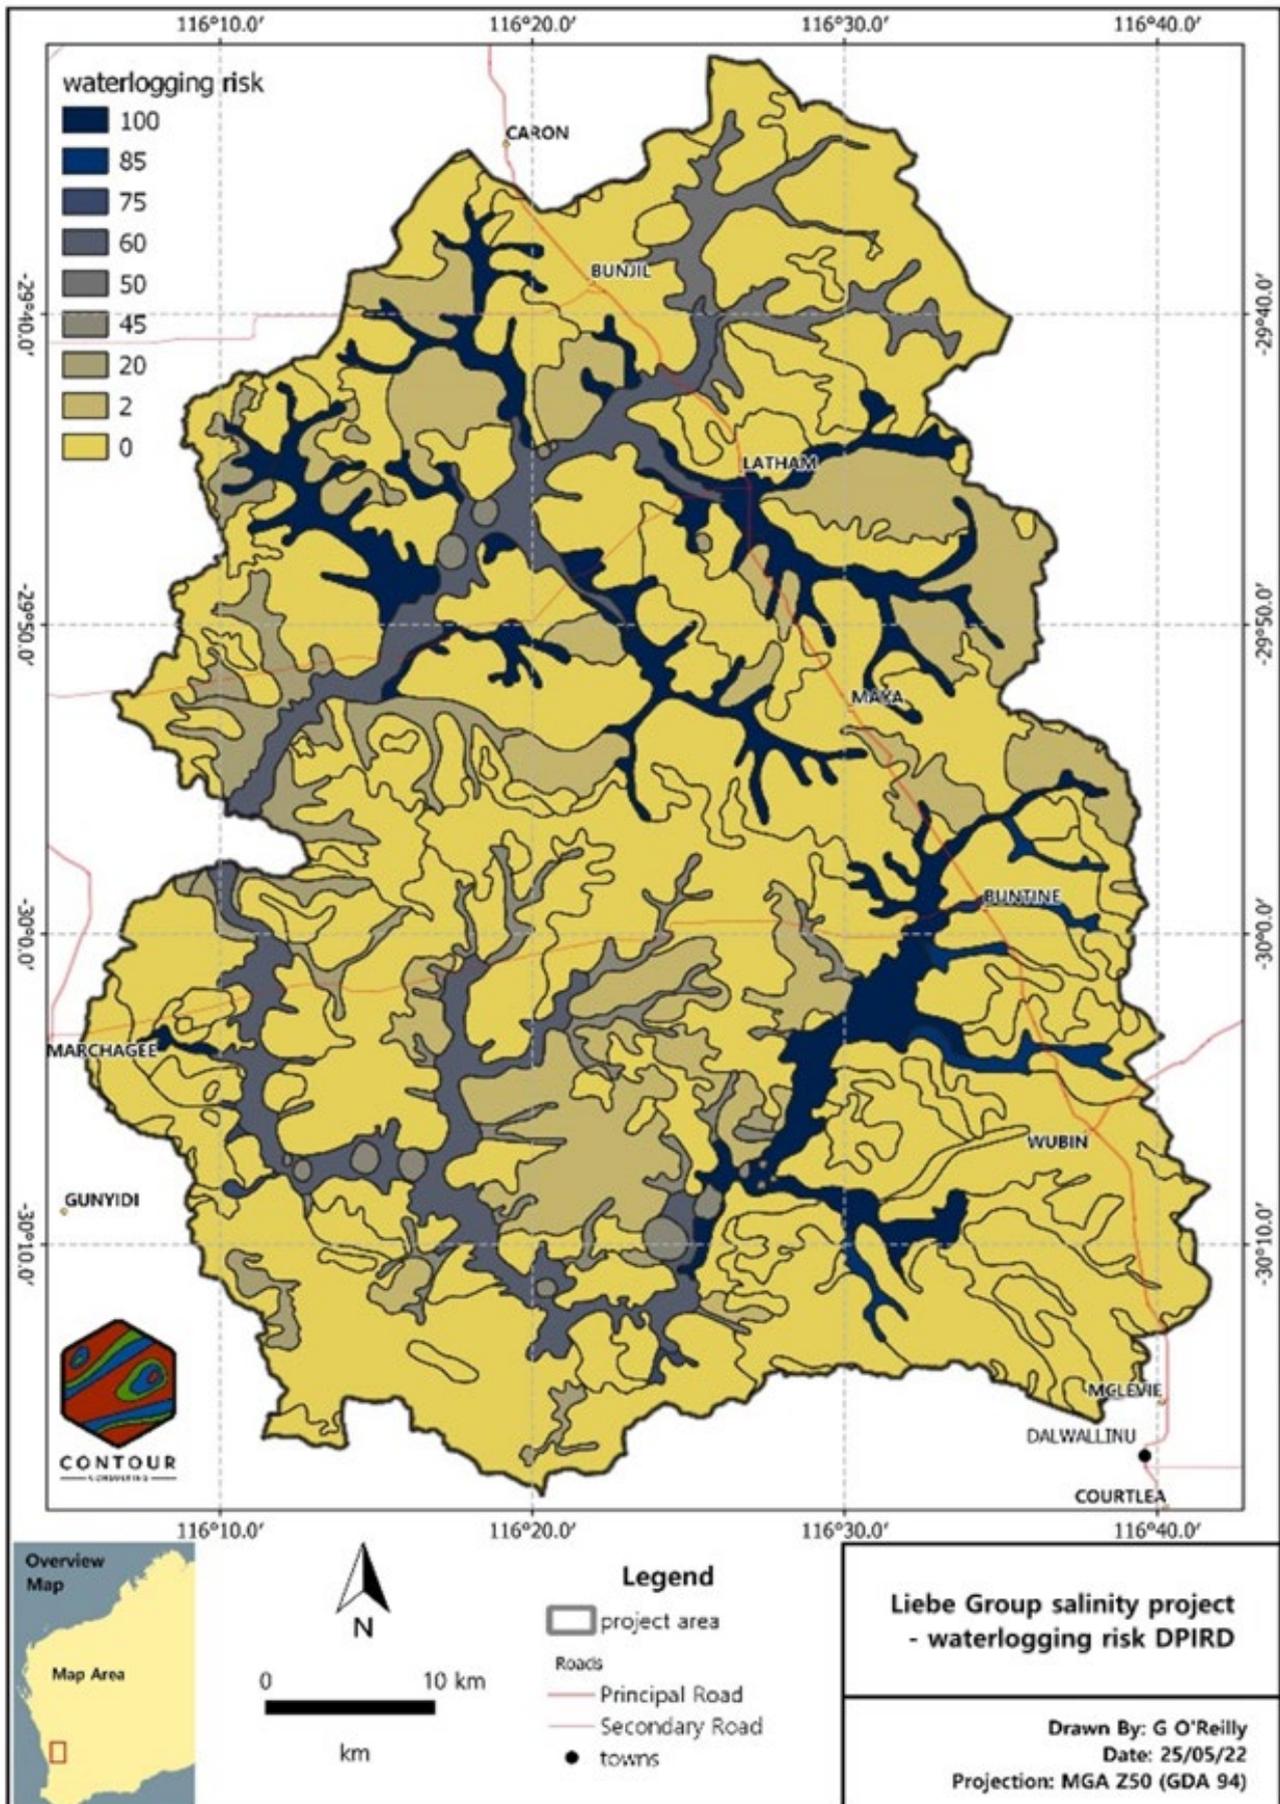
Figure 6.4 Waterlogging risk in the Liebe Group salinity project catchment

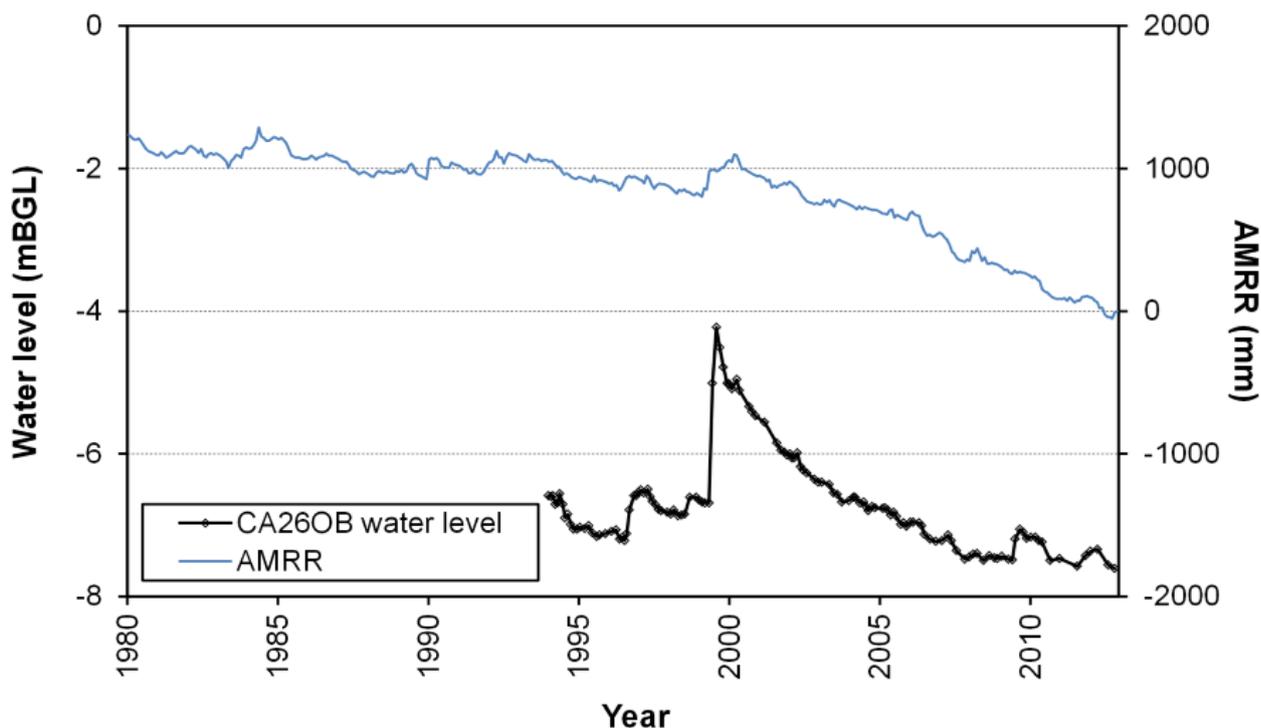
Figure 6.6 Hydrograph for bore CA26OB with accumulated monthly residual rainfall for Carnamah (CA26OB) – from (Raper, et al. 2014)

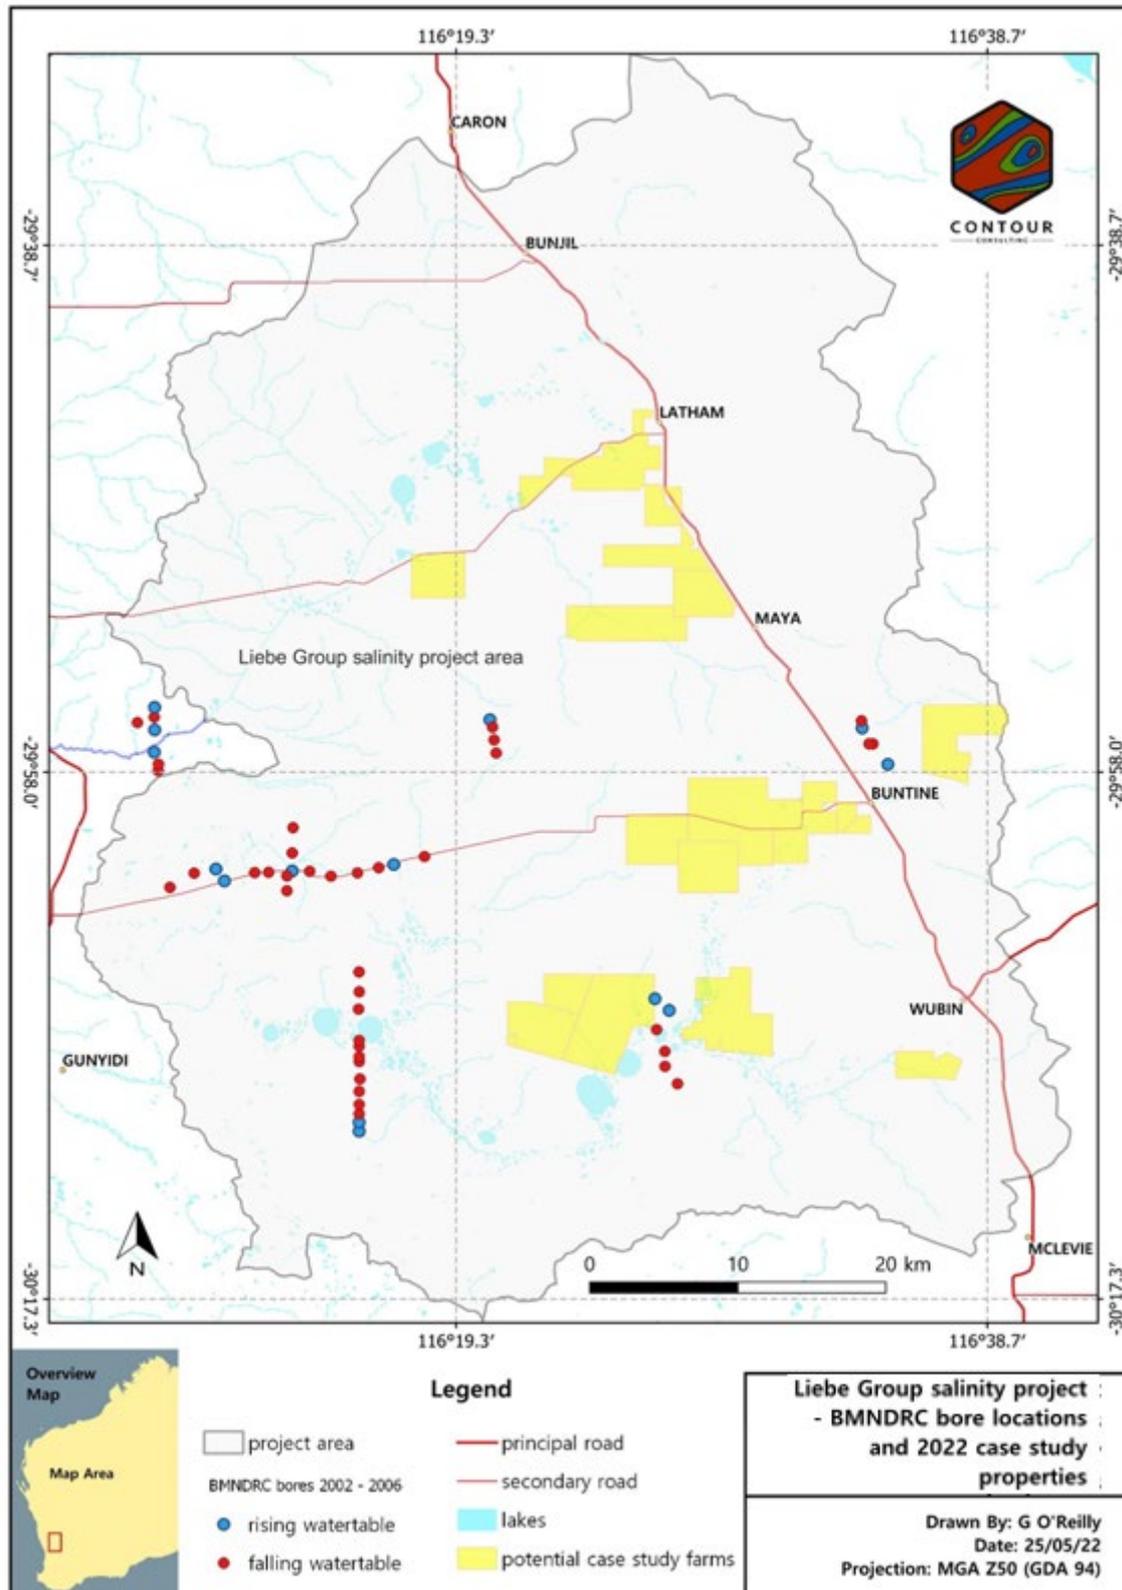
Figure 6.7 Location of BMNDRC bores installed in 2002 and groundwater trend when measured in 2006 by (URS 2008)

2002 to 2006. There were 10 bores where groundwater had risen (on average by 0.23 m) and a much higher number of bores (38) where groundwater levels dropped during that time (on average by 0.69 m). Four monitoring bores were dry to the depth drilled in both 2002 and 2006. Figure 6-7 shows the distribution BMNDRC bores in relation to potential case study farms in the current Liebe Group project, and whether they had rising or falling water tables between 2002 and 2006.
