# Redefining dryland salinity for a new generation of land managers

**Liebe Group**

**Contour Environmental and  
Agricultural Consulting**

July 2022

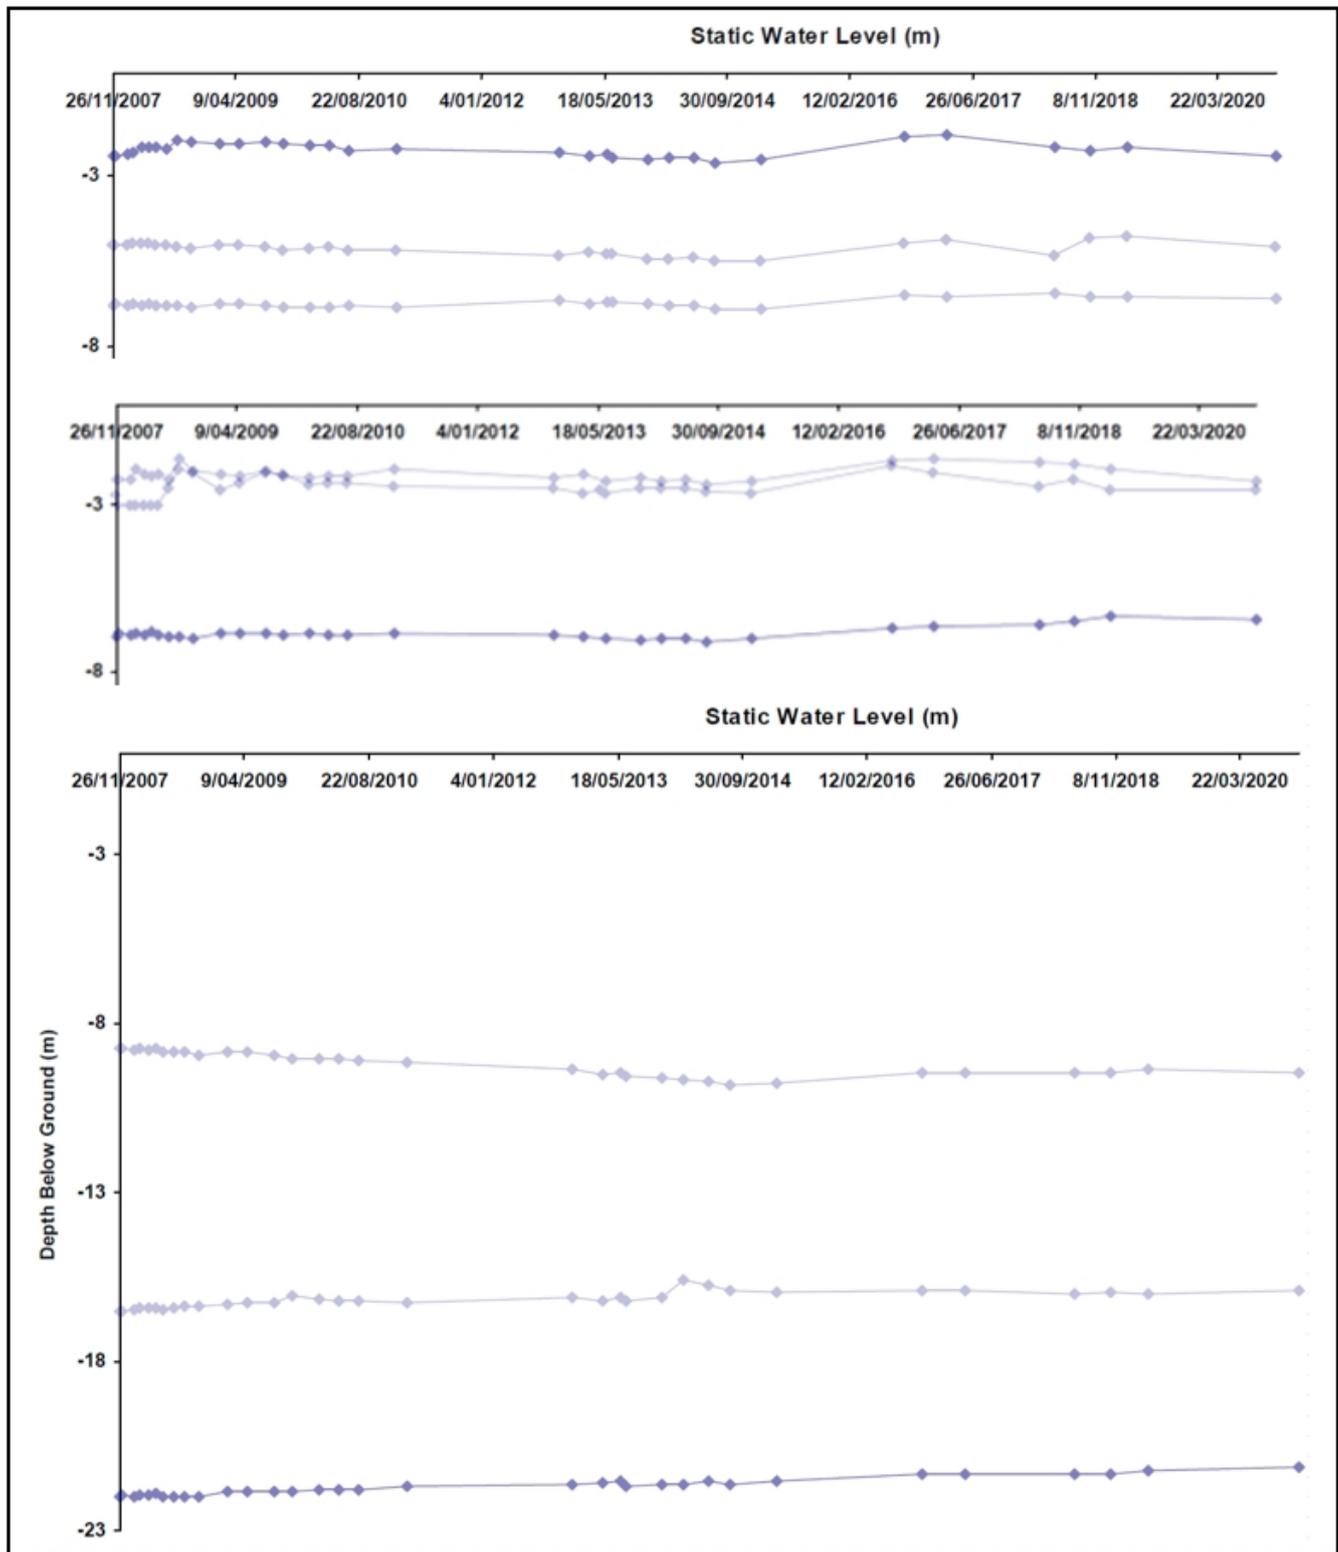
Figure 6.9 Hydrographs of Pithara bores (DPIRD RCM project) with groundwater levels 2007-2021 (Liebe Group and Russell Speed DPIRD)

Despite a decline in monitoring of groundwater levels in areas affected by dryland salinity since the early 2000s, some recent results from near the project catchment are available. The Resource Condition Monitoring (RCM) program (Speed, Kendle and Gibbon 2008) established representative groundwater monitoring sites at a soil landscape zone level, and regular monitoring has been maintained 2007-2021 at a series of nine bores just to the southeast of the project catchment. Figure 6-8 shows the location of the bores and Figure 6-9 the drill logs provided by Russell Speed (DPIRD) through the Liebe Group for this review. No bores show dramatic change in groundwater level over 13 years. Bores with shallower water tables do show some seasonal fluctuations, especially soon after construction, and again around 2016, but are virtually at the same, or around the same level in 2007 and 2020. Deeper water tables have shown only small trends over 13 years with changes in the order of about one metre rise for the deepest section of the water table and a relatively steady state for other bores. One bore, with a water table at about 9 m shows a slight drop over 13 years.

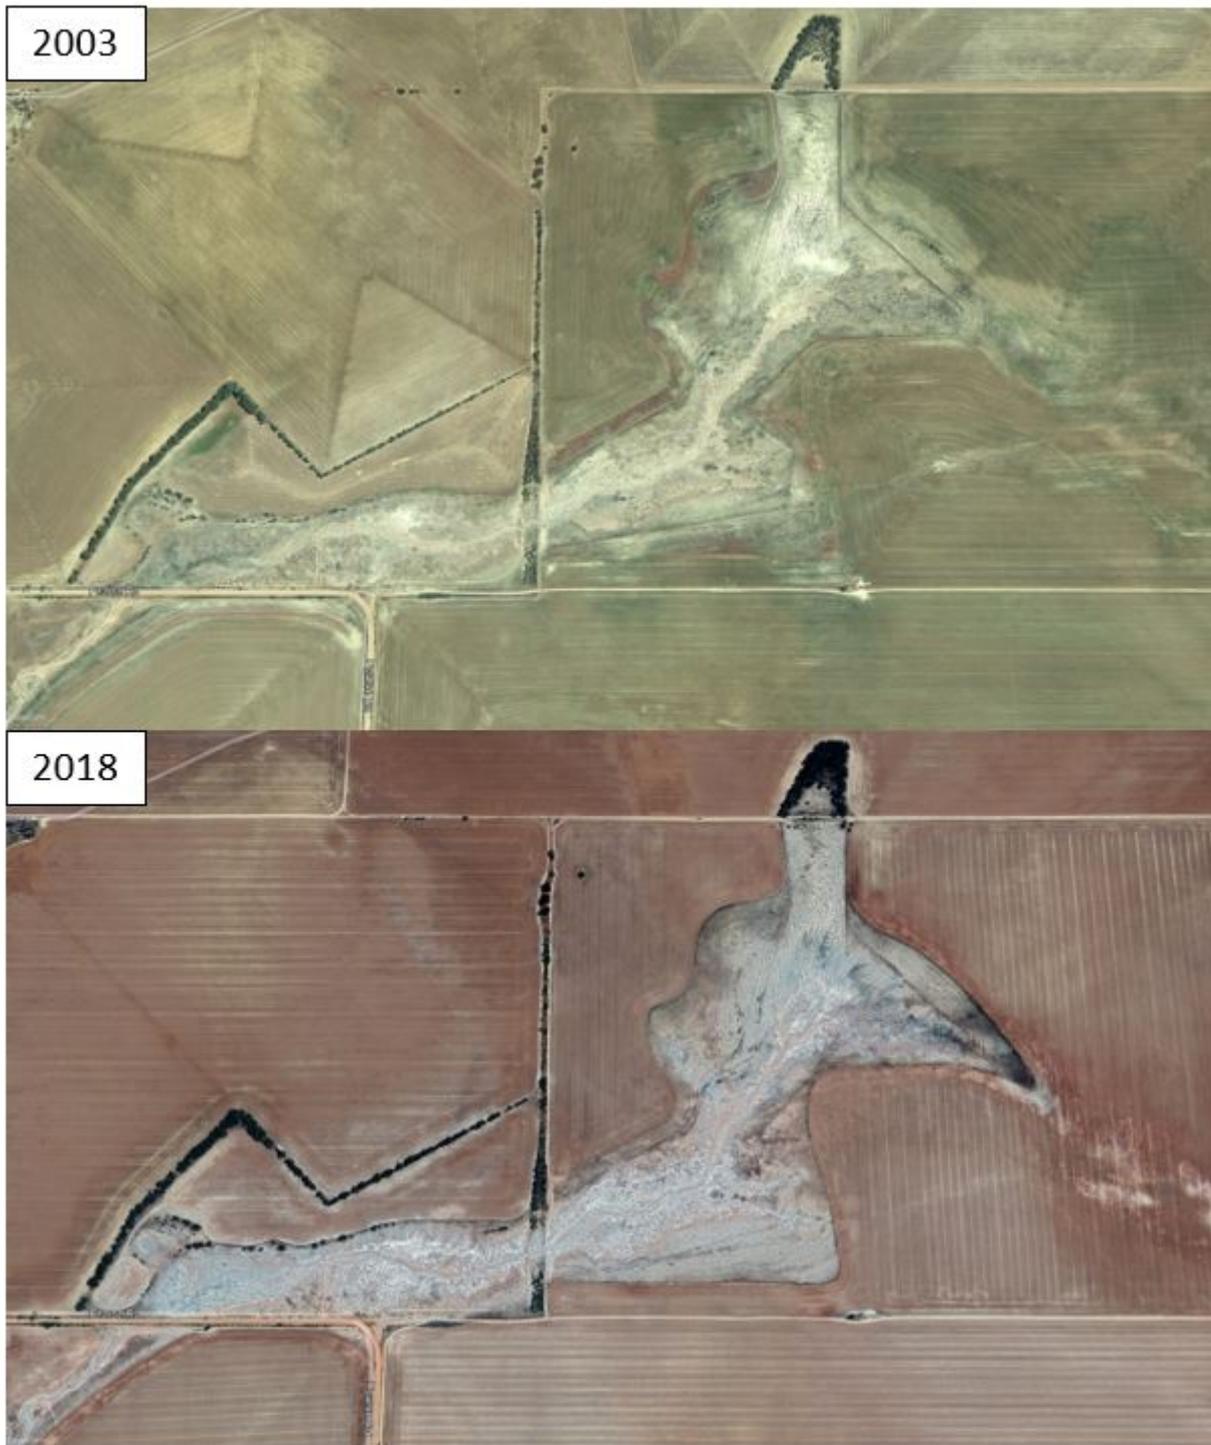
Figure 6.10 Changes to salinity 2003-2018 at a typical saline scalded area in the project catchment

but also changes such as when on ground works were implemented. Platforms like Google Earth™ have a feature that allows users to compare historical images with more recent views. Figure 6-10 shows a typically salt affected area in the project catchment between 2003 and 2018 with no groundwater drainage constructed. The spread of salinity appears stable but with some expansion to the area unable to be cropped. The faint lines visible in the 2003 image were possibly the edge of non-cropping soil up to the wet year in 1999. A cropped area to the east is showing signs of salinity affecting production in the 2018 image.

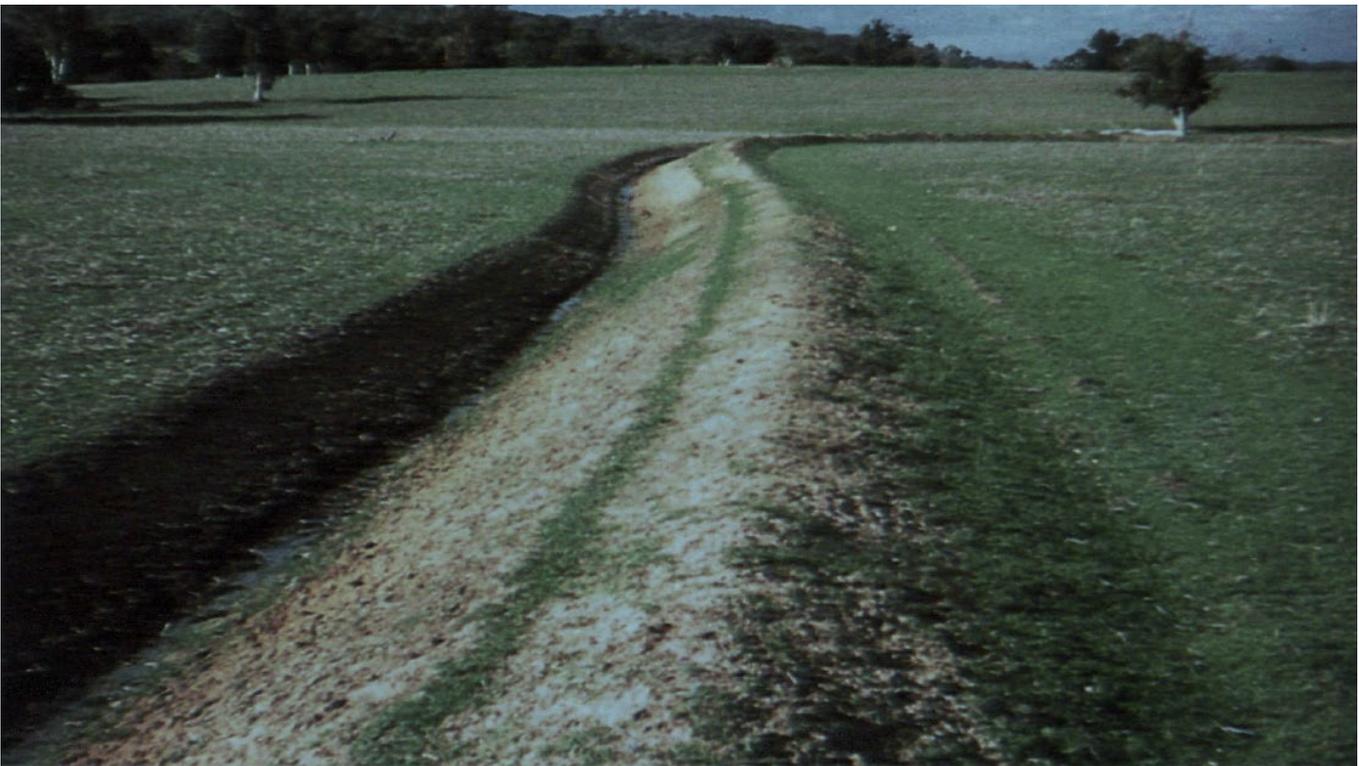
**Figure 7.2** Reverse interceptor drain (from (McFarlane and Cox 1990))

The difference between seepage interceptor drains (reverse interceptor drains) and normal grade banks is that interceptor drains divert surface flow but also capture and divert the shallow sub-surface seepage that often occurs on duplex soils, which have a permeable topsoil overlying a shallow clay subsoil. Figure 7-2 shows a typical reverse interceptor drain.

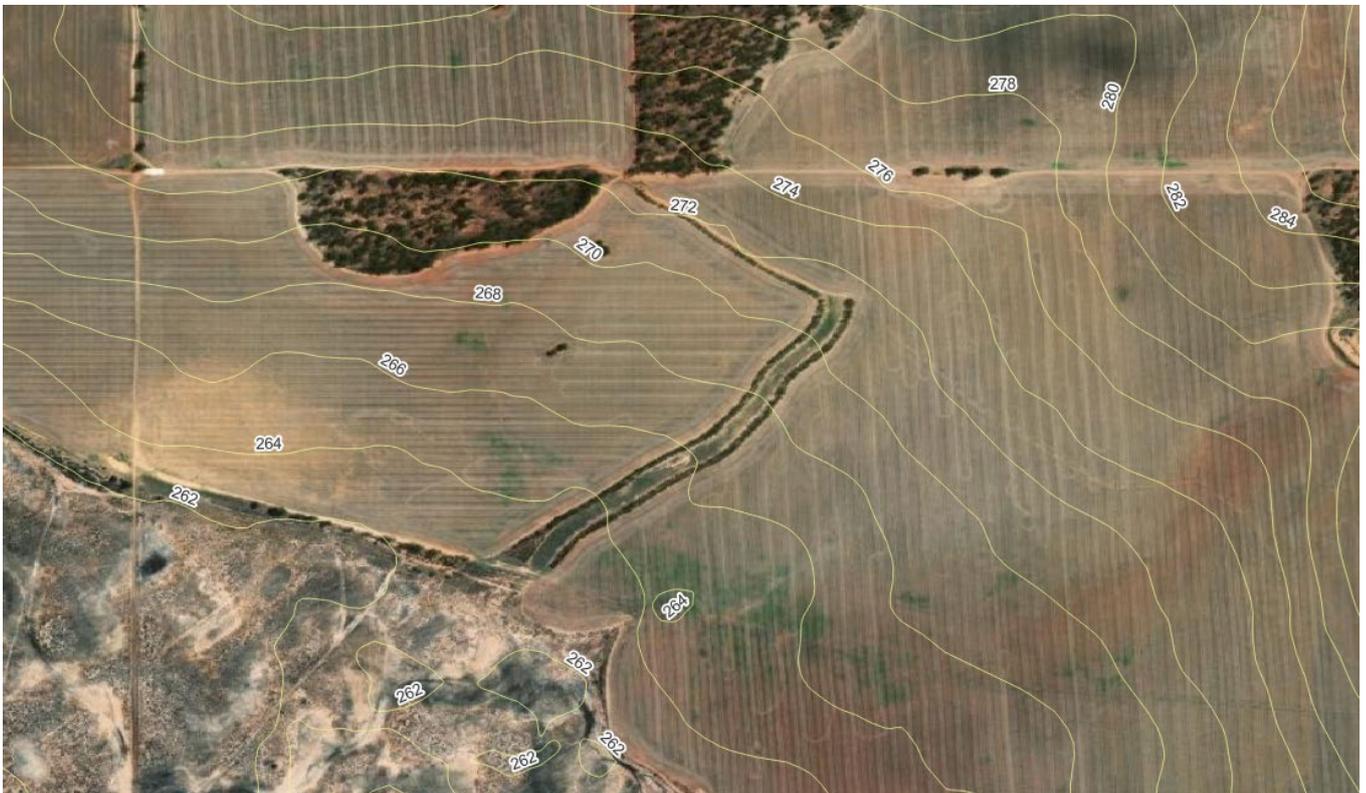
Figure 7.3 Grade bank and grassed waterway in the project catchment

Figure 7-3 below shows a good example of a grade bank and grassed waterway in the project catchment disposing of excess surface water into the creek system.

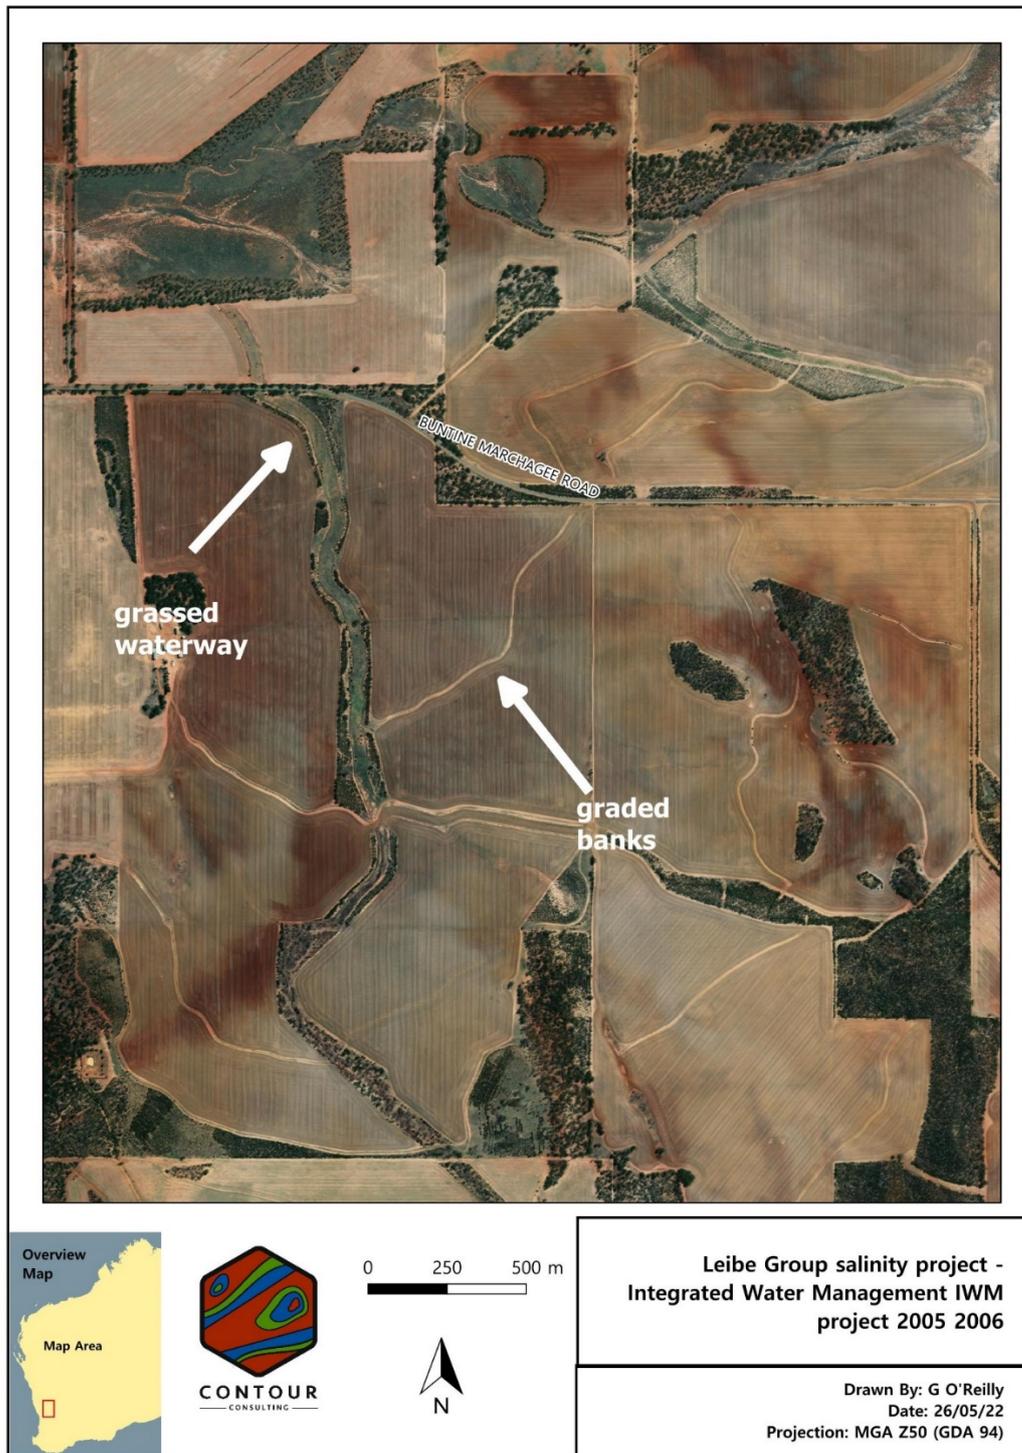
Figure 7.4 Location of initial demonstration site in the IWM on-ground works project 2005-2011

Figure 7-4 below shows a recent satellite image of the original demonstration site for the IWM project, constructed in 2005/06 with grade banks feeding into a levied grassed waterway. Figure 7-5 is the corresponding Google Streetview™ image from November 2020 where improved culverts were installed along the Buntine-Marchagee Rd.

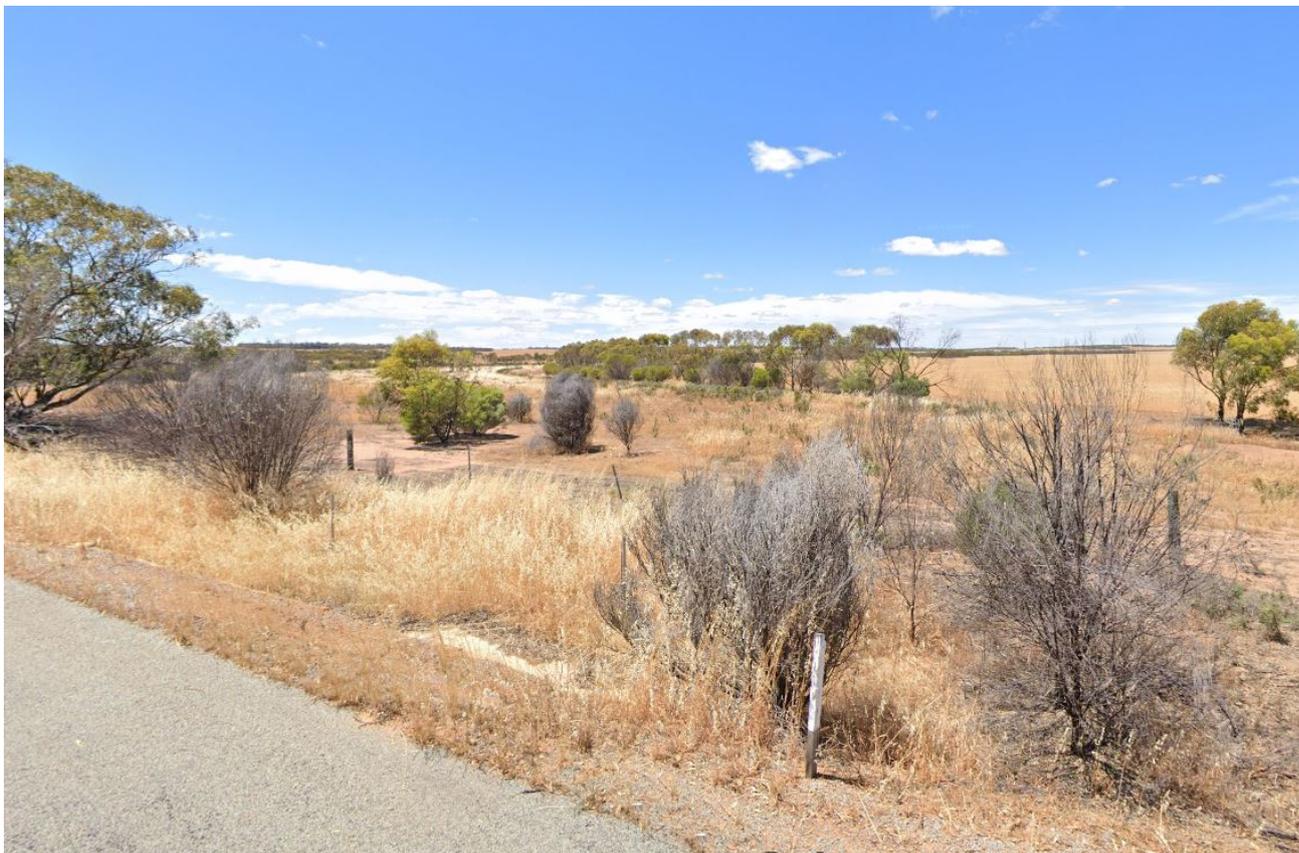
**Figure 7.5** Grassed waterway constructed in 2005 flowing under the Buntine-Marchagee Road (GoogleMaps™ Nov 2020)

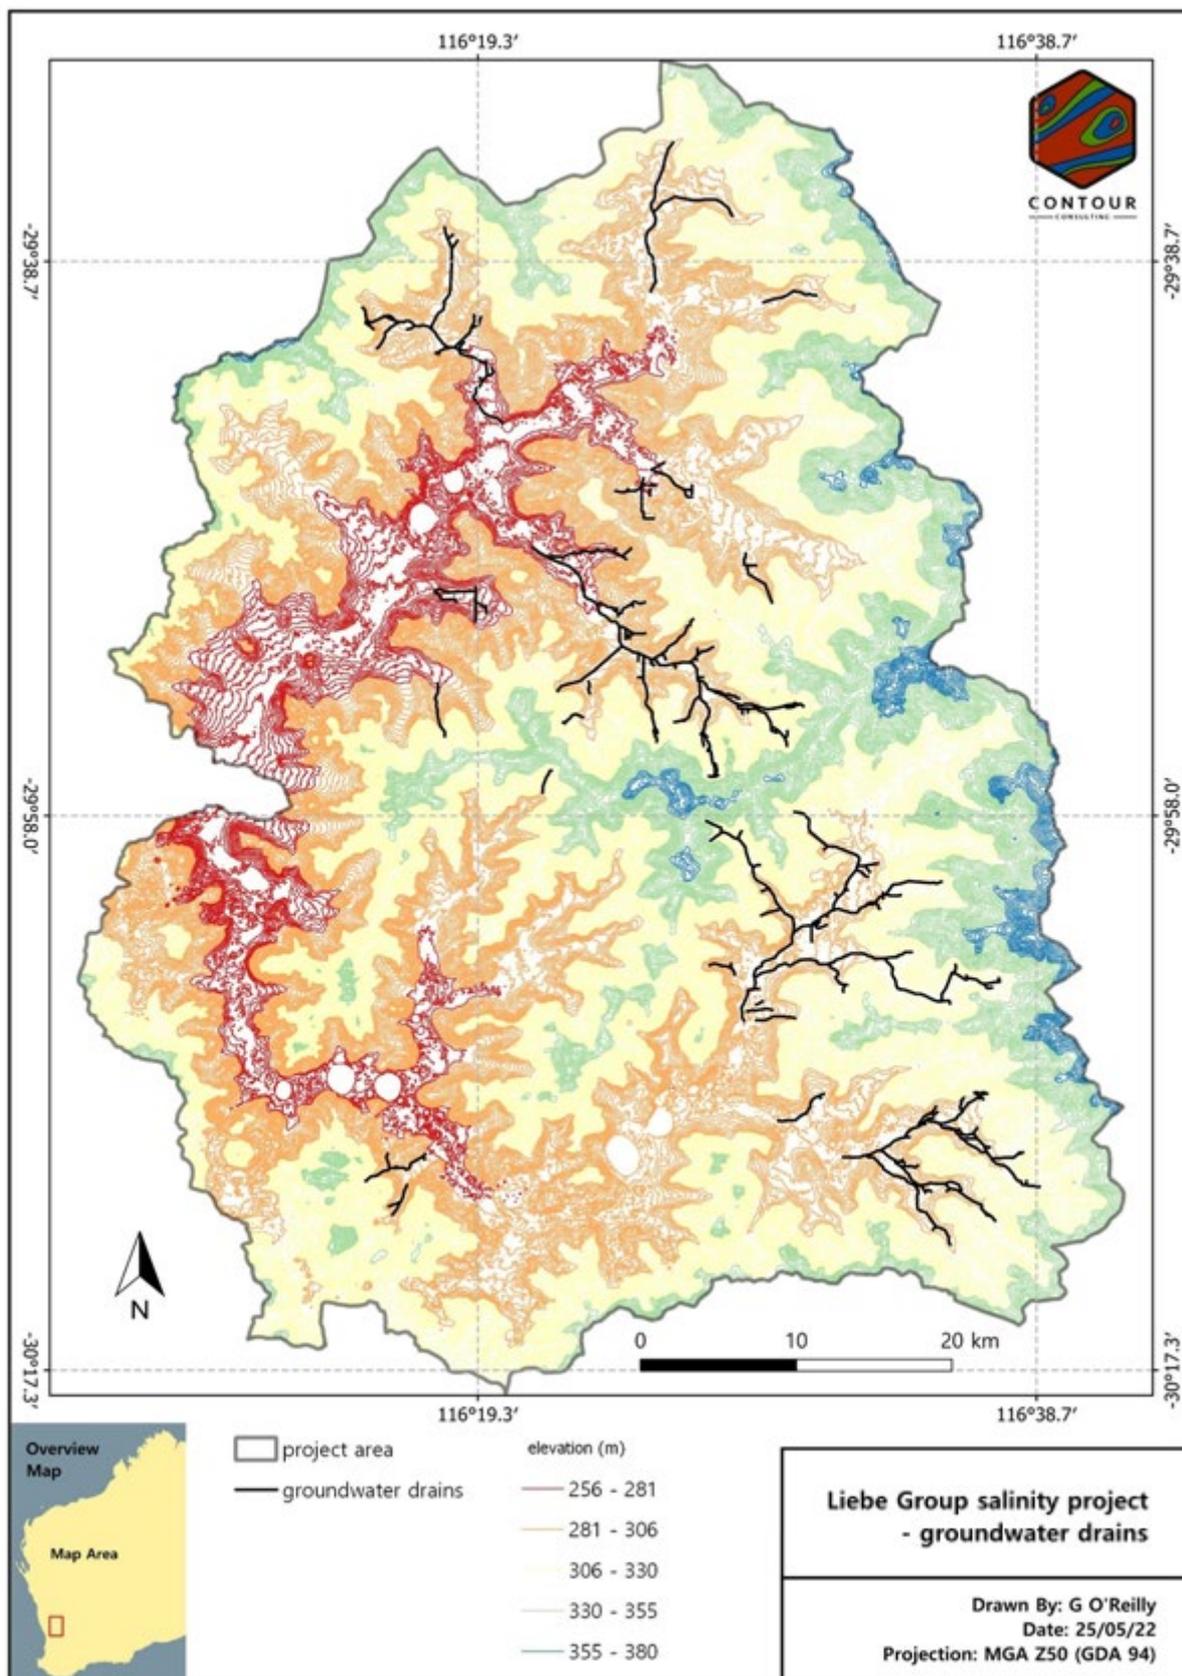
**Figure 7.6** Groundwater drains in the Liebe group salinity project catchment

Deep drains have existed in the project catchment for many decades and are visible on 1985 satellite imagery. Imagery sequences in the project catchment show the ongoing development of groundwater drains. There were only a few drains visible in the 1980s but there is now at least 317 km of linked drains through multiple properties disposing into waterways or salt lakes as shown below in Figure 7-6.

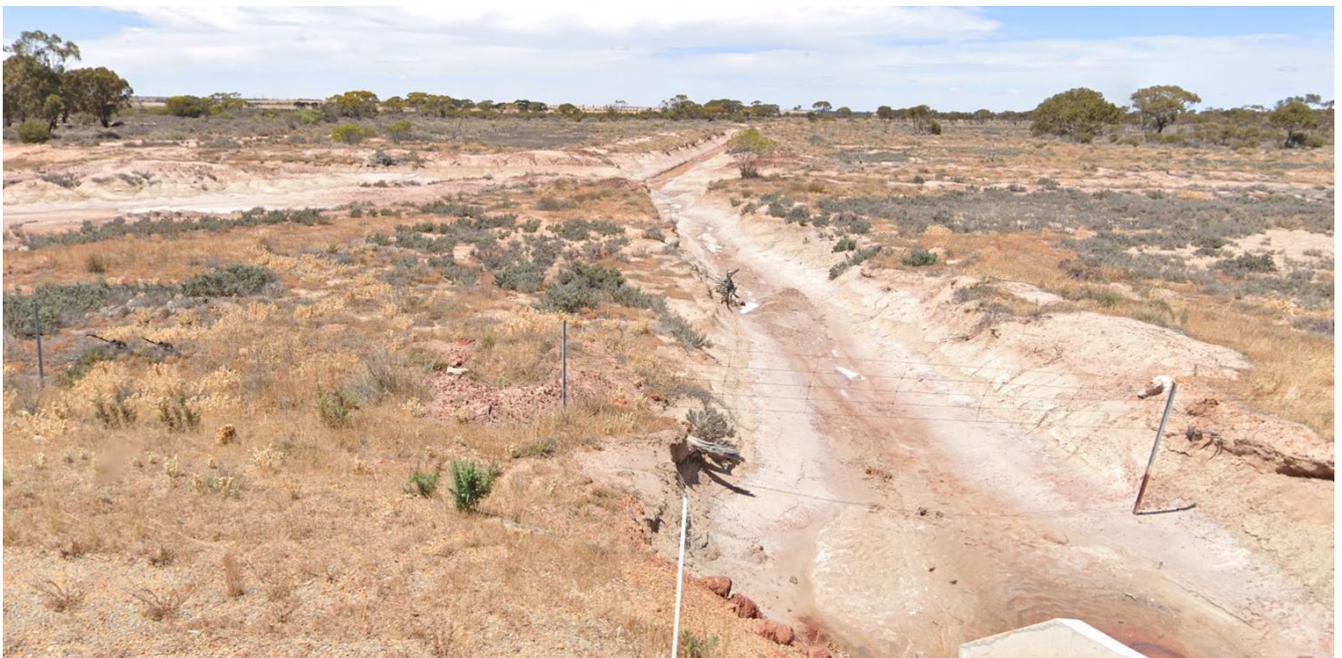
**Figure 7.7** Typical groundwater drain in the Liebe Group salinity project catchment. From Google™ Streetview™

It has been found that loamy and silty-sand topsoils and upper soil profiles are more predisposed to erosion than medium to heavy clay subsoils. In more saline environments, the combination of soil erosion caused by dispersion and slaking, as well as windblown material, can quickly silt up some ground water drains. Channel silting can be most noticeable where the drain is open to surface water runoff (Cox 2010). Figure 7-7 shows a typical drain in the project catchment where silting and erosion has occurred near a road culvert.

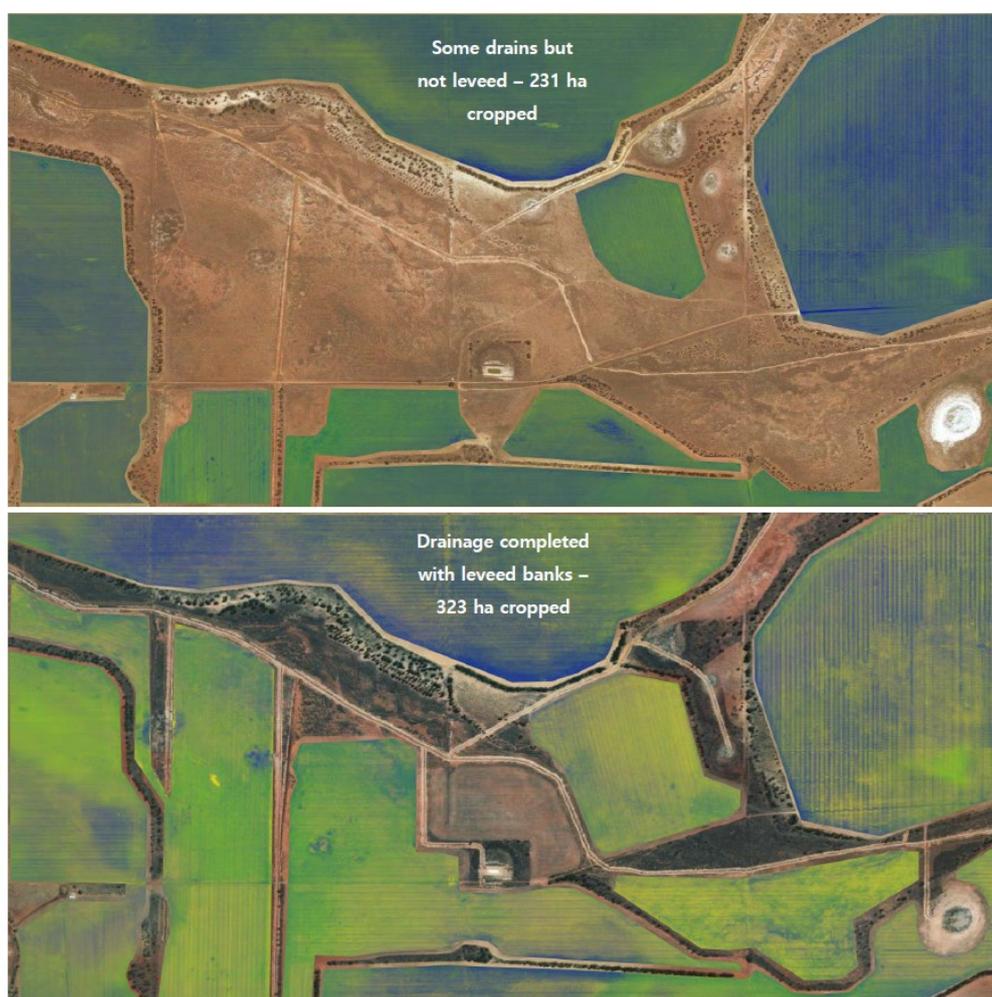
Figure 7.8 Increased cropping area following drain construction on a farm in the project catchment

There is some evidence in the project catchment that there is more cropping now than in the past adjacent to some drains. For example, Figure 7-8 below shows an area that had some drainage visible in an older satellite image, though not extensive or in good condition. A later image shows the drains had been refurbished or reconstructed, and that other drains and disposal areas added, and the area cropped appears increased. The problem is there are too many unknown factors to assume the drains have been the effective intervention. For example, the cropping program may have become a greater priority, and the areas in the first satellite image were arable but were not cropped. It could be that the significant decline in rainfall over 20 years has dropped the water table with or without drains. It could also be that the drains are placed higher in the landscape and are, in fact, adequate for de-watering the sub catchment they occupy. Either way it is a good result for this landholder.
